Century Elementary School Safety Study

Final Report

August 2004

**Grand Forks/East Grand Forks
Metropolitan Council of Governments**

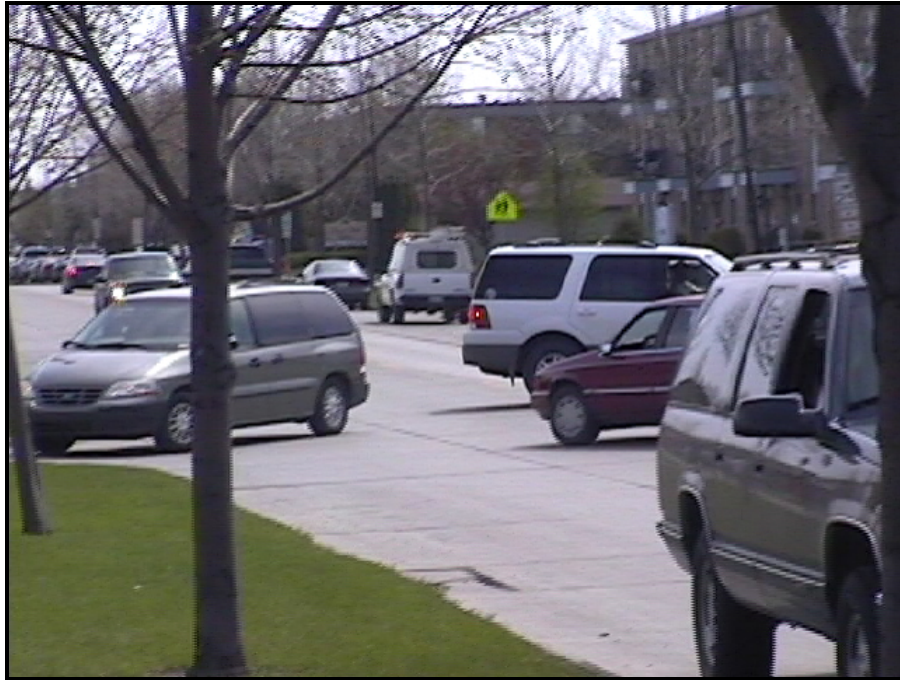
Several negative driving maneuvers were observed along 34th St. Vehicles blocking lanes/crosswalks and parking violations were among the most frequent problems. Examples of blocking violations include vehicles performing southbound left turns that would block the northbound through traffic at both the north and south parking lot accesses (as shown in Figure 2). In addition, a few vehicles leaving the south parking lot onto 34th St. did not yield to the pedestrians in the crosswalk (as shown in Figures 3 and 4).

Figure 2. Left turning vehicle blocking through traffic.

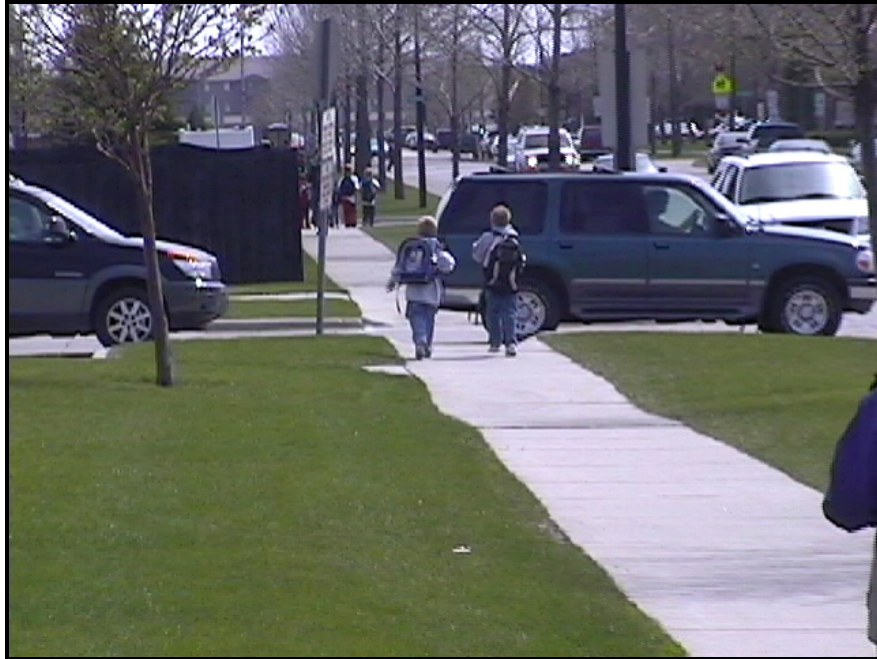
Figure 3. Vehicle blocking crosswalk leaving the south parking lot.

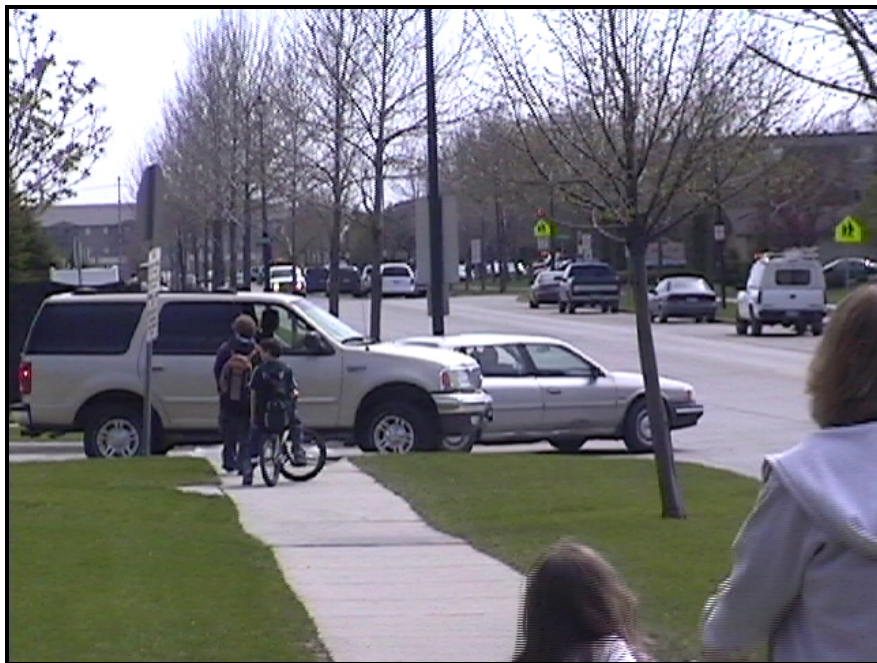
Figure 4. Vehicles blocking crosswalk leaving the south parking lot.

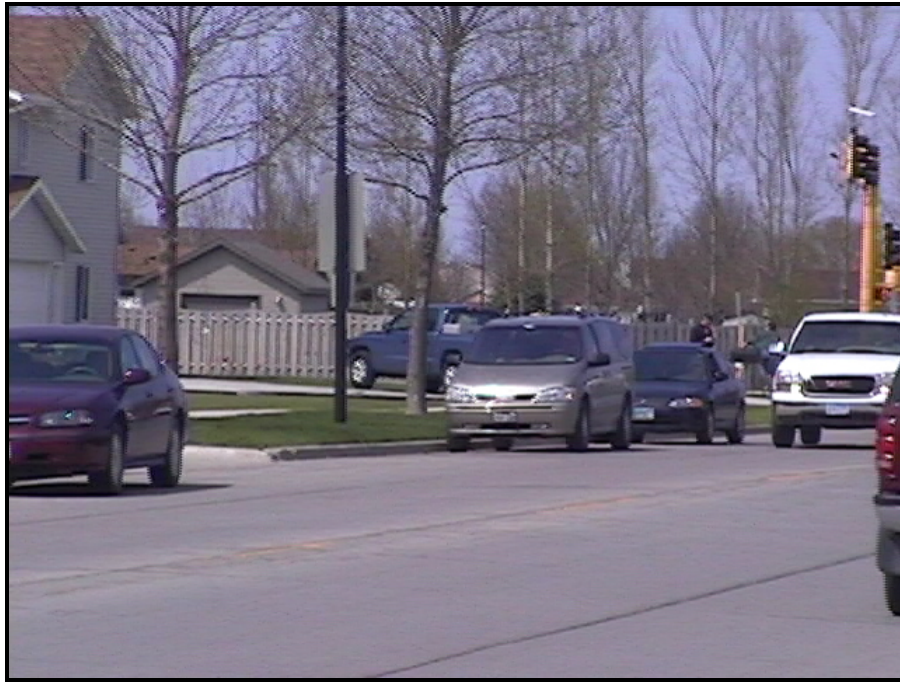
Improper or illegal parking along 34th St. was also observed. Some parents picking up children parked very close to the intersection of 34th St. and 17th Ave. S. thus partially blocking vehicles to travel southbound while vehicles were making a northbound left turn. An example of the illegal parking is shown in Figure 5.

Figure 5. Illegal parking on 34th St. in close proximity to 17th Ave. S.

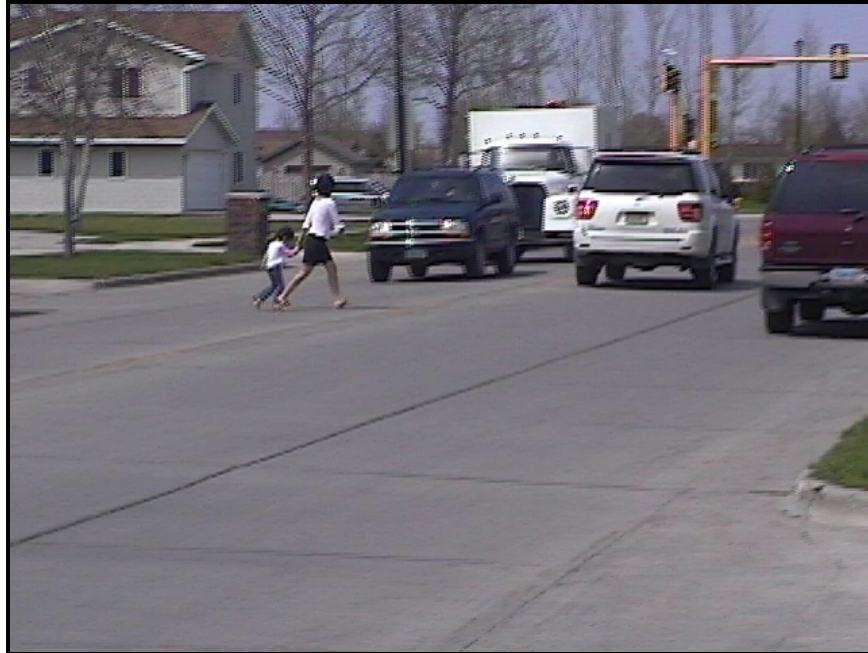
Parking on the west side of 34th St. makes parents and children cross the street at random locations without using a crosswalk. This occurrence increases the number of vehicle/pedestrian conflicts, which then increases near misses and accident risks (note Figures 6 and 7). Parking on the east side of 34th St. is not permitted; several vehicles use that side during the afternoon dismissal period. During our observation, vehicles parking on the east side of 34th St. queued from north parking lot to the south parking lot.

Figure 6. Unsafe crossing of 34th St.

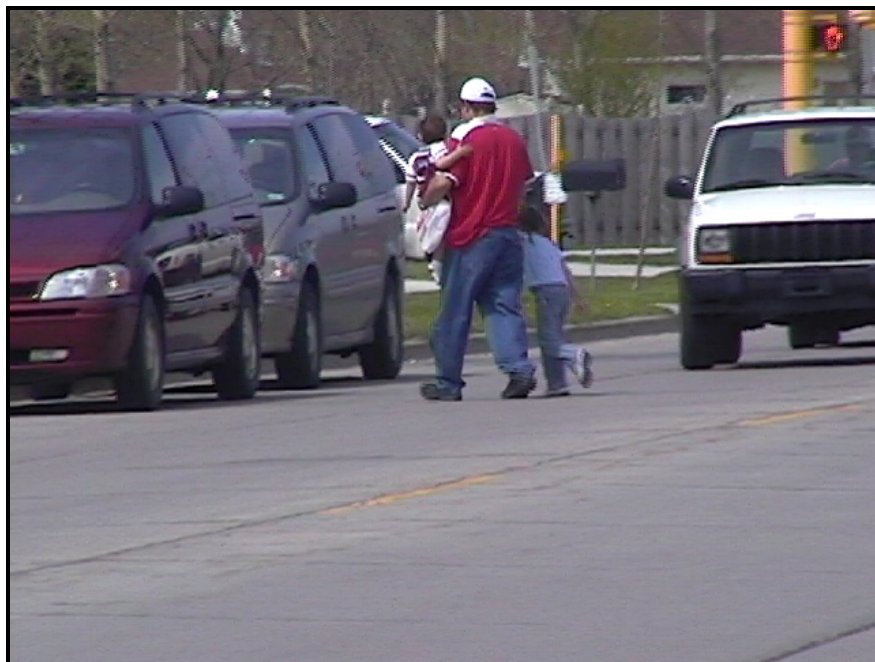
Figure 7. Unsafe crossing of 34th St.

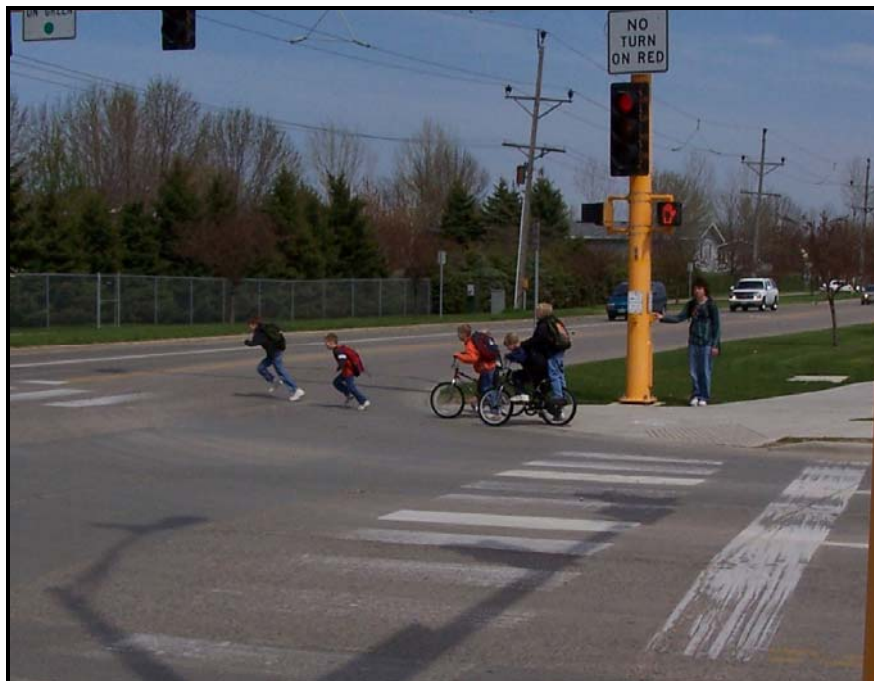
street, which were provided by the SAFE KIDS Walk This Way Campaign (Figure 8). Students were observed running across the street on several occurrences when they were provided the WALK indication. This may be due to the anxiousness to get home or they felt they only were able to cross the street during WALK indication (Figure 9).

Figure 9. Students crossing 17th Ave. S.

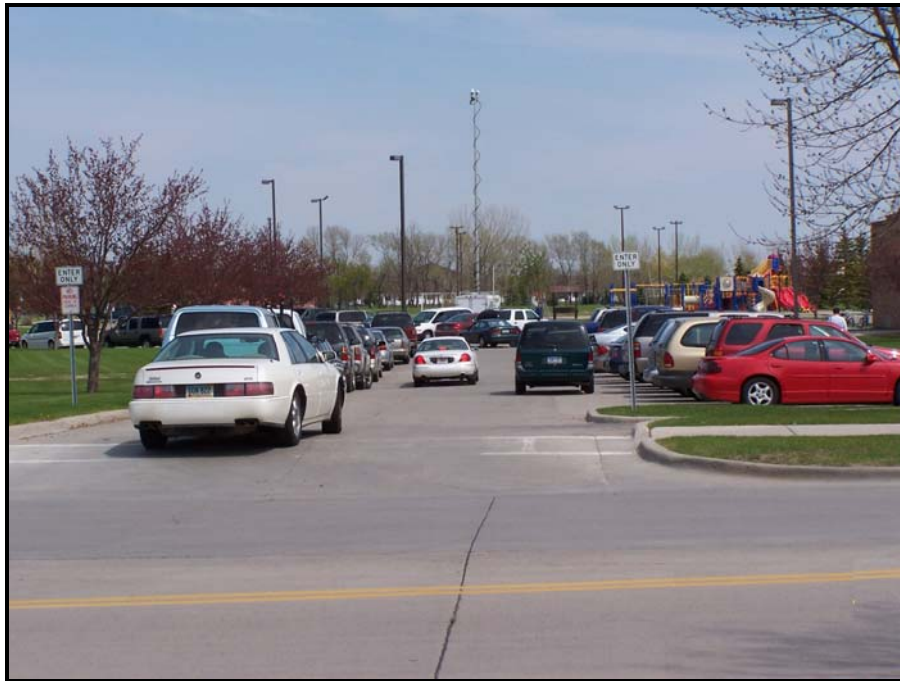
The north parking lot and access road serves as the primary pick-up and drop-off point for parents. The area in front of the school becomes heavily congested during the school peak periods, which lasts 10-15 minutes. The access road has parallel parking on the north side, 90-degree parking on the south side, and a through lane which is wide enough to accommodate two lanes of traffic. Therefore, vehicles sometimes are stacked three wide in addition to the perpendicular parking, which makes it difficult for vehicles to leave the spaces (Figure 10). Several vehicles are left unattended at various locations that prevent other vehicles from exiting the parking lot.

Figure 10. Vehicles picking up children in the north parking lot.
