School Safety Study for Lewis & Clark, West, and New Heights Elementary Schools

Final Report

Prepared for:
Grand Forks – East Grand Forks Metropolitan
Planning Organization

Prepared by:
Advanced Traffic Analysis Center
Upper Great Plains Transportation Institute
North Dakota State University
Fargo, North Dakota

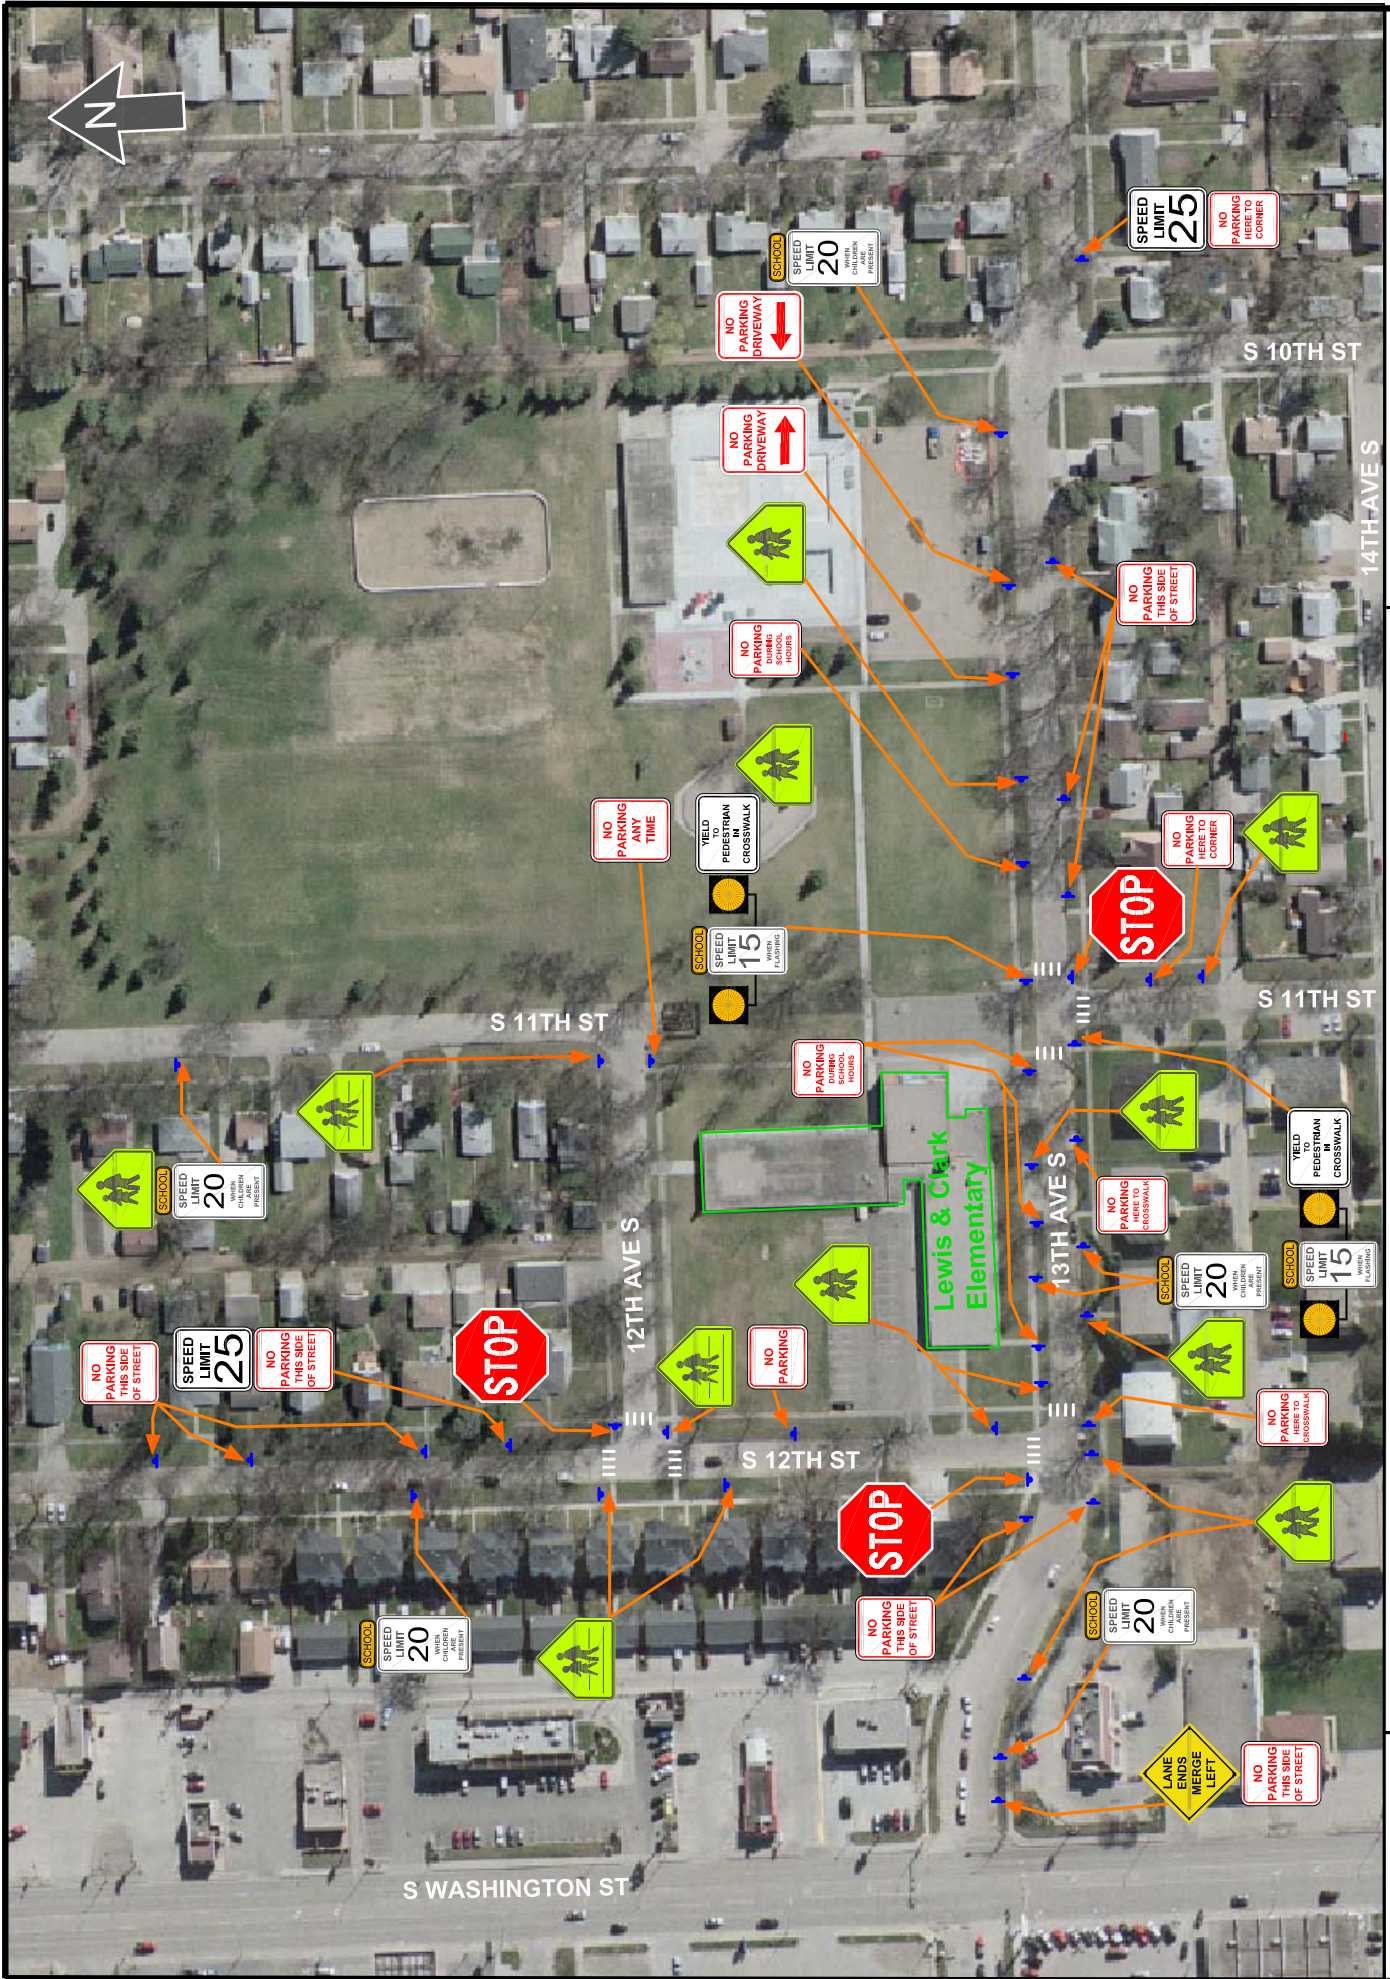
Lewis and Clark Elementary school is bordered by roads on three sides, with a staff parking lot located on the west side of the school. The parking lot has a driveway which provides access to S. 12th St. South 12th St. is a two-lane local street which runs north-south on the west side of the school, and carries an average daily traffic volume (ADT) of 1,725 vehicles (2005 traffic counts). South 12th St. terminates at the intersection with 13th Ave. S., on the southwest side of the school. Thirteenth Ave. S. is located on the south side of the school, and is a two-lane collector which has a 2005 ADT of 4,750 vehicles. The roadway which borders the north side of the school is 12th Ave. S., which is only one block in length. The intersection of S.12th St. and 12th Ave. S. is a T-intersection, where 12th Ave. S. terminates. The east side of 12th Ave. S. joins into S.11th St. via a 90° turn to the north. The ADT for 12th Ave. S. was not available, but due to the location and orientation of the roadway, the traffic volumes should be relatively low in comparison with surrounding roadways. To the south of the school, 13th

Lewis & Clark Elementary: Existing Conditions

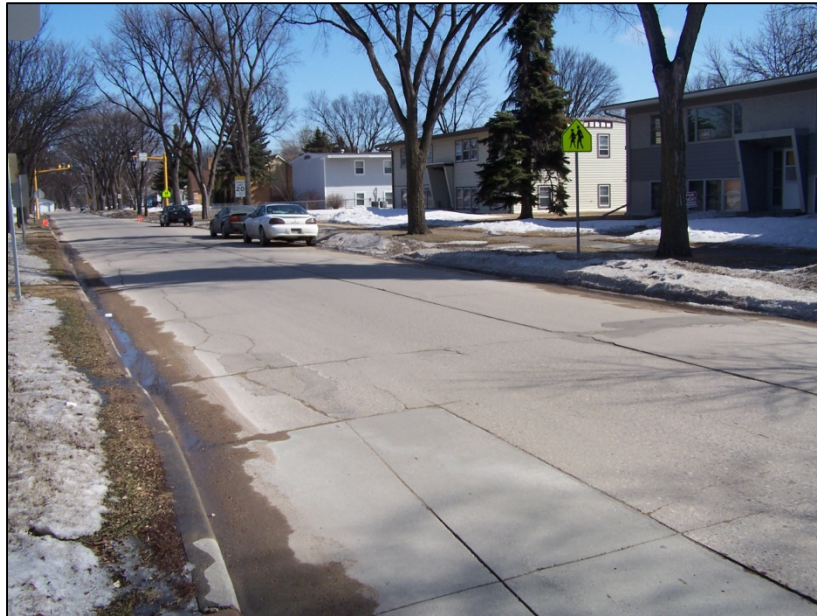
Although a majority of students are dismissed to the south via the main doors, only a few parents were parked along 13th Ave. S. approximately 10 minutes prior to dismissal (Figure 4.1). Several vehicles were parked along S. 12th St. adjacent to the staff

Figure 4.1. Parking on 13th Ave. S. prior to dismissal

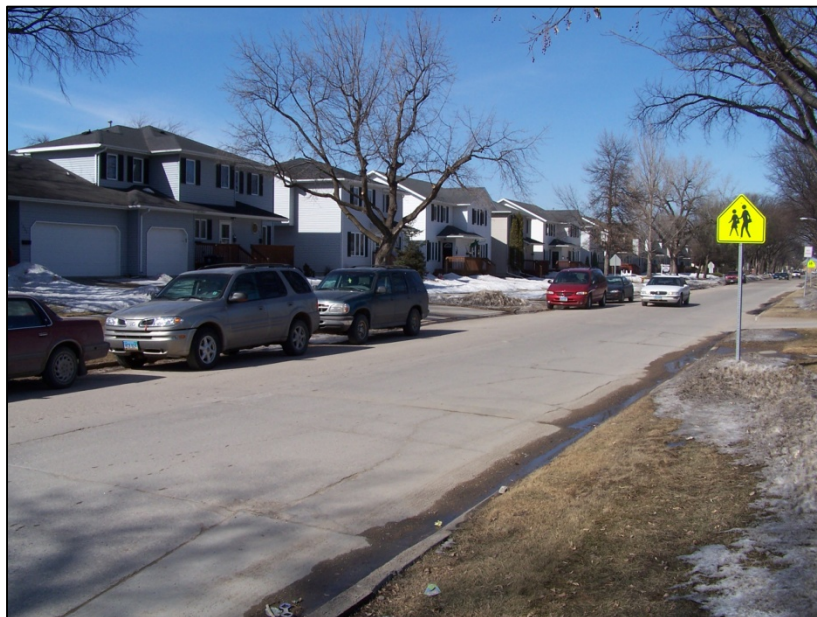
parking lot, however, a majority of them were unoccupied (Figure 4.2). In addition, only a few vehicles parked on S. 11th St., south of the main doors of the school, prior to dismissal.

Figure 4.2. Parking on S. 12th St. prior to dismissal

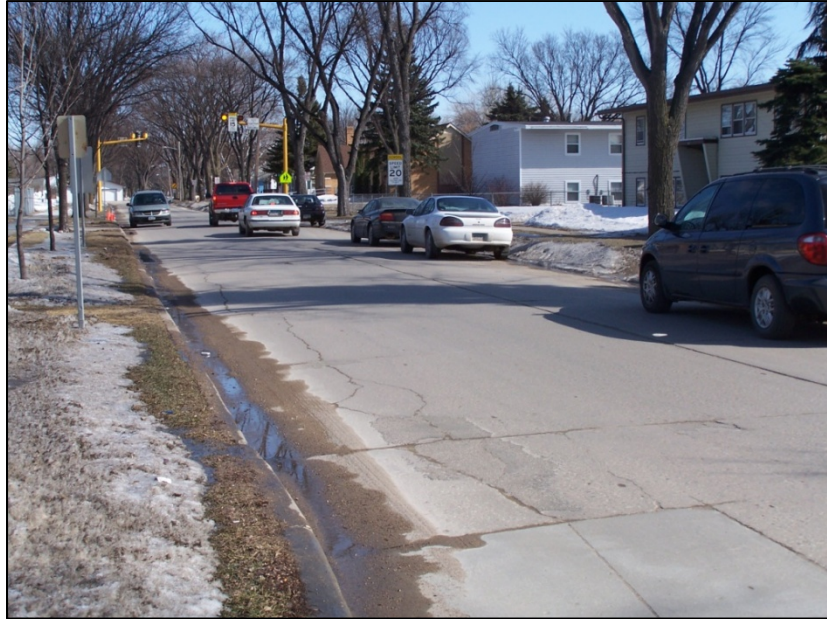
During dismissal, the number of vehicles along 13th Ave. S. increased, but vehicle flow remained unimpeded. During the dismissal time, the flashing beacons at the pedestrian crossings were activated, which served as a reminder to motorists that the speed limit was reduced due to increased pedestrian activity (Figure 4.3).

Figure 4.3. Parking on 13th Ave. S. during dismissal

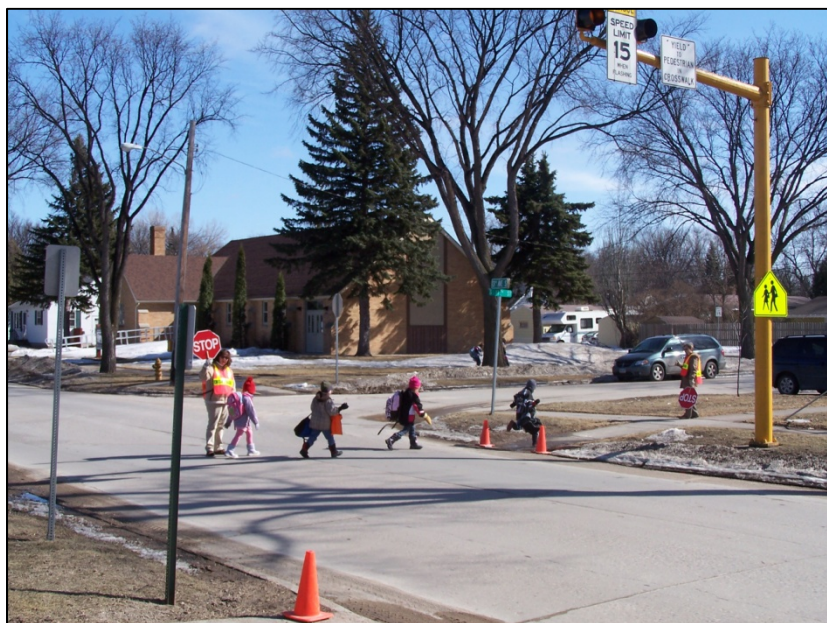
The pedestrians in the vicinity of the main doors on the south side of the school were monitored by staff members, and the pedestrians crossing 13th Ave. S. and S. 11th St. were monitored by two staff members serving as crossing guards (Figure 4.4).

Figure 4.4. Pedestrian crossing on 13th Ave. S.

During the site visit, it was observed that several staff members serve as crossing guards during dismissal. This practice is extremely beneficial to the safety of students, and should be continued. Both crossing guards at the intersection of 13th Ave. S. and S. 11th St. were wearing fluorescent safety vests, and carried stop signs to warn oncoming vehicles of pedestrian activity. On the north side of the school, the crossing guard also had a stop sign, but was not wearing a safety vest. It is recommended that all crossing guards at the school wear reflective, fluorescent, safety vests to increase their visibility to oncoming traffic.

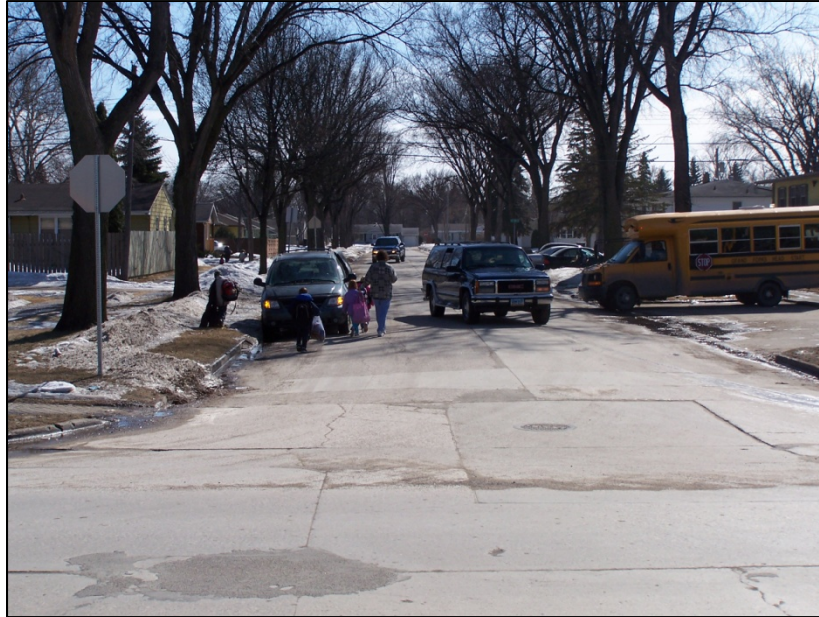
Several parents parked along S. 11th St., to the south of the school. The pedestrian activity as a result of loading children into the vehicles at this location caused temporary lane blockages (Figure 4.5). However, the volume of traffic using S. 11th St. was reasonably low and no significant safety issues were observed.

Figure 4.5. Parking on S. 11th St. during dismissal

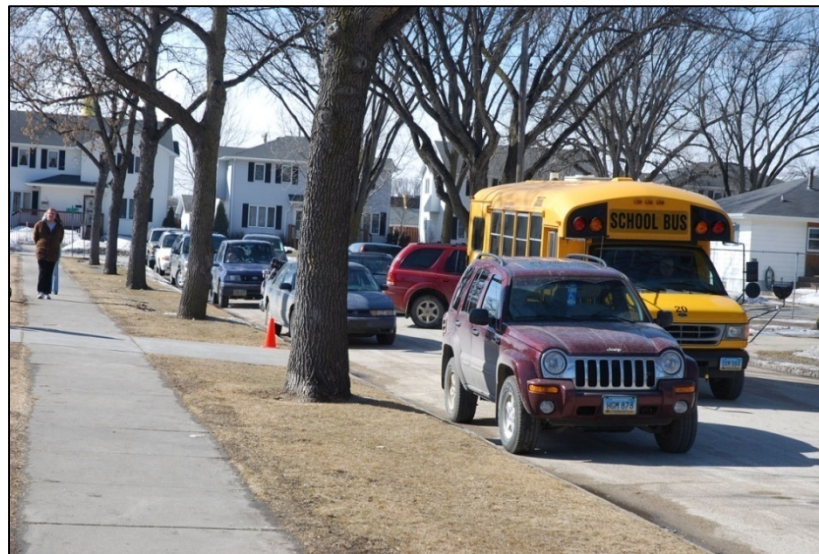
On the north side of the school, a few vehicles parked adjacent to the school approximately 10 minutes prior to dismissal. During the dismissal, vehicles were lined up along the curb adjacent to the school on 12th Ave. S. In addition, several vehicles were parked adjacent to the compost collection site at the intersection of 12th Ave. S. and S. 11th St. (Figures 4.6 and 4.7). It should be noted that parking is restricted at all times in front of the compost collection site.

Figure 4.6. Bus loading on 12th Ave. S.

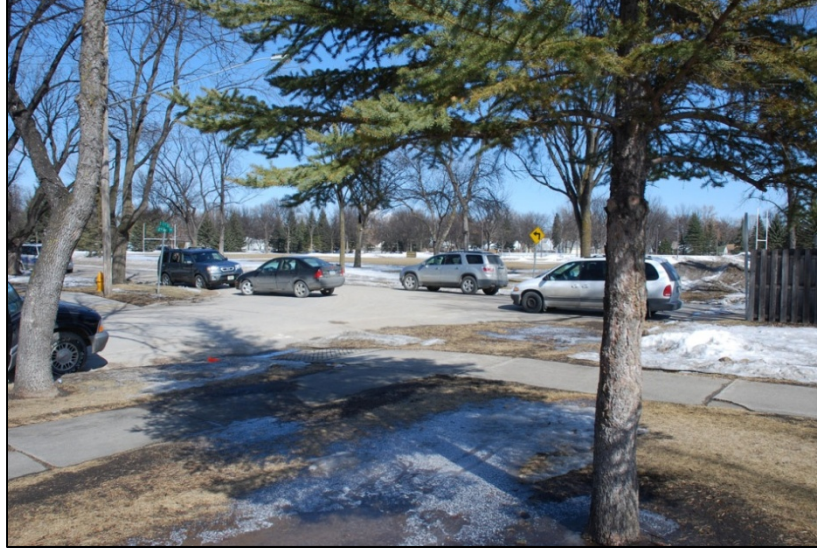
Figure 4.7. Parking in front of the compost collection site

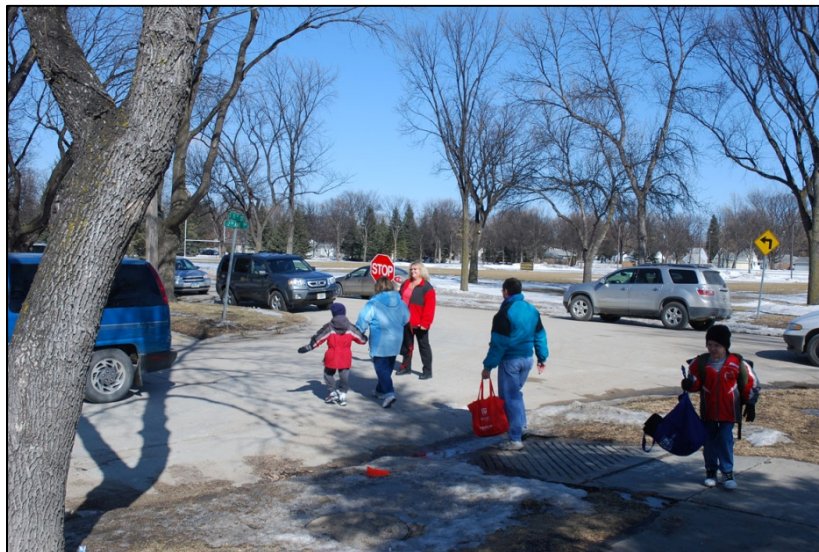
Pedestrian activity on the north side of the school primarily consisted of parents walking into the school and walking out with their children. Traffic flow along 12th Ave. S. was significantly increased during the dismissal, and flow was impeded due to both the number of vehicles in the vicinity and the location of the school bus, which was present after dismissal. A school staff member served as a crossing guard, and monitored the pedestrian and vehicle movements at the intersection of 12th Ave. N. and S. 11th St. The presence of the crossing guard was beneficial to making drivers aware of the crossing, and giving pedestrians a safe place to cross 12th Ave. N. (Figure 4.8).

Figure 4.8. Pedestrian crossing on 12th Ave. S.

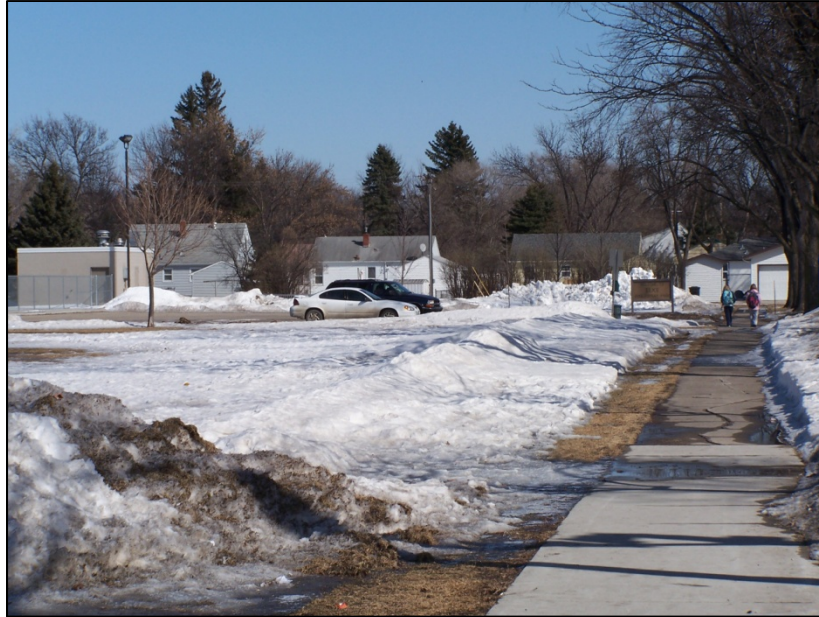
Parents were also observed parking in the Elks Pool parking lot to the east of the school (Figure 4.9). According to school officials, this location is a recommended parking area for parents picking up students during dismissal. This allows a safe access to the school since there are no streets to cross, and is relatively close to the school.

Figure 4.9. Parking in the Elks Pool parking lot

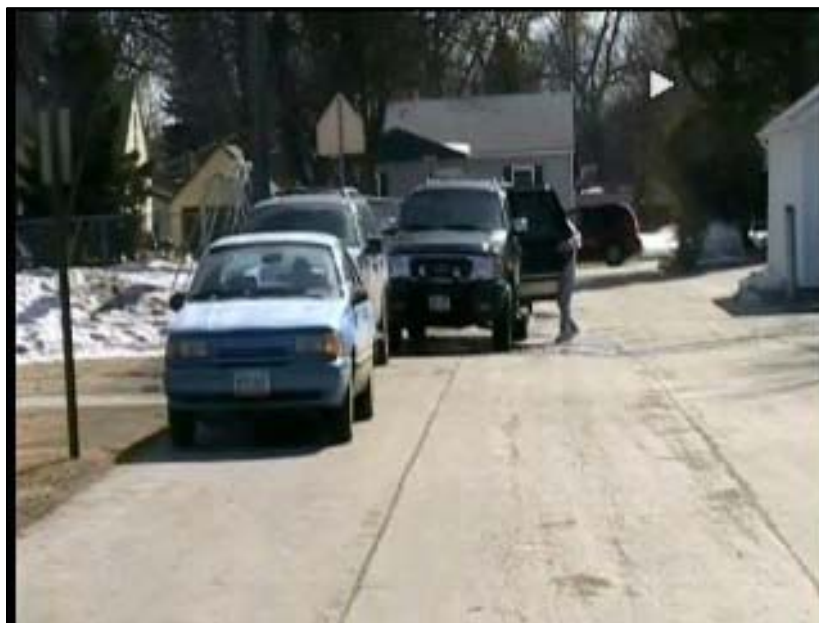
Students at West Elementary School are dismissed from three locations around the school: 1) the main doors to the east of the school; 2) the south side of the school adjacent to the staff parking lot; and 3) the west side of the school adjacent to the alley on the north side of the school. Prior to dismissal, parents were parked at various locations around the school, primarily along the alley to the west of the school and N. 25th St. on the east side of the school (Figures 4.10 and 4.11).

Figure 4.10. Parking in the west alley prior to dismissal

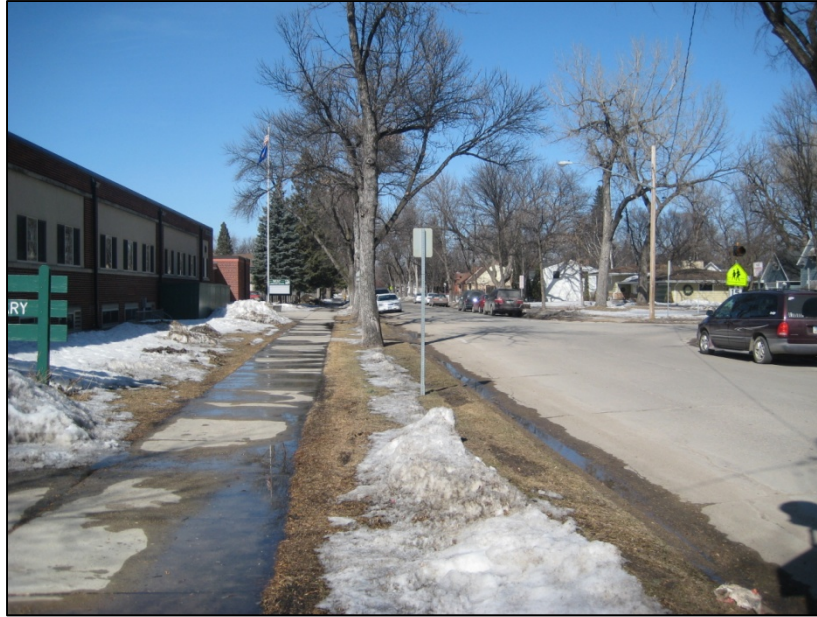
Figure 4.11. Parking on N. 25th St. prior to dismissal

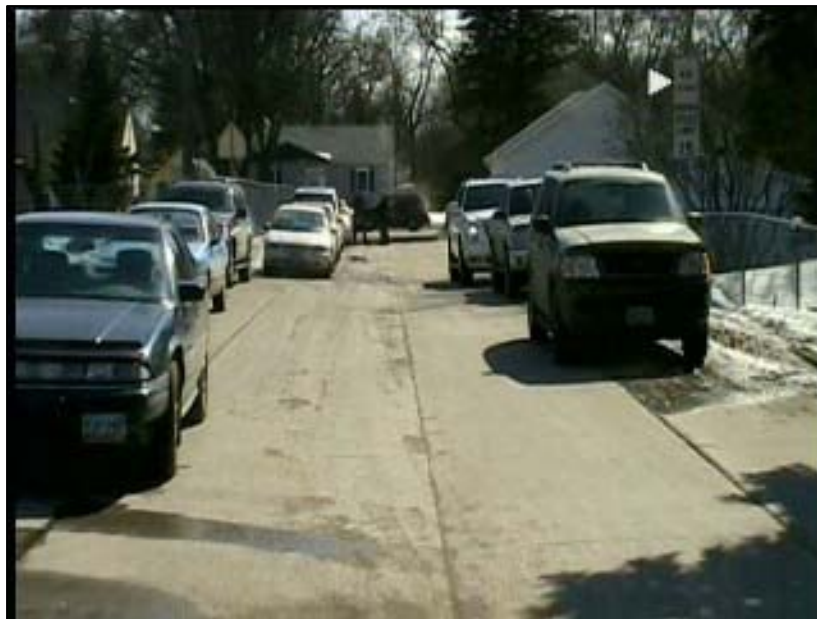
The operational characteristics in the west alley and Columbia Ct. were observed during the dismissal process, due to some safety concerns by staff and parents. Although the west alleyway is designed for two-way operations, parents use it as a one-way roadway (northbound) during dismissal. In addition, parents were observed parking along both the east and west side of the alley, which caused an impedance for northbound vehicles (Figure 4.12). It should be noted that no vehicles were observed driving southbound in the alleyway during dismissal.

Figure 4.12 Parking in the west alley during dismissal

The second recommendation addresses the issues observed in the west alley and the north side of the school. Since the school property extends to include the east-west portion of the unpaved alley on the north side of the school, it is recommended that the alley be paved, and a one-way access road be constructed along the north side of the school. This extension will provide additional access to N. 25th St., and will serve as an alternative to the alleyway which extends to the north. The one-way operation will help to maintain efficient traffic flow around the school. In addition, diagonal parking is proposed along the north side of the school, accessed by the new roadway. This will provide additional parking for school faculty and staff. A bus turn-out lane was also added to the alleyway on the west side of the school. The re-location of the bus loading to the west side of the school creates a safer environment for students, as the busses are removed from surrounding roadways. Cost estimates for each of the long-term recommendations range from \$16,100 to \$78,900 (Table 5.2).

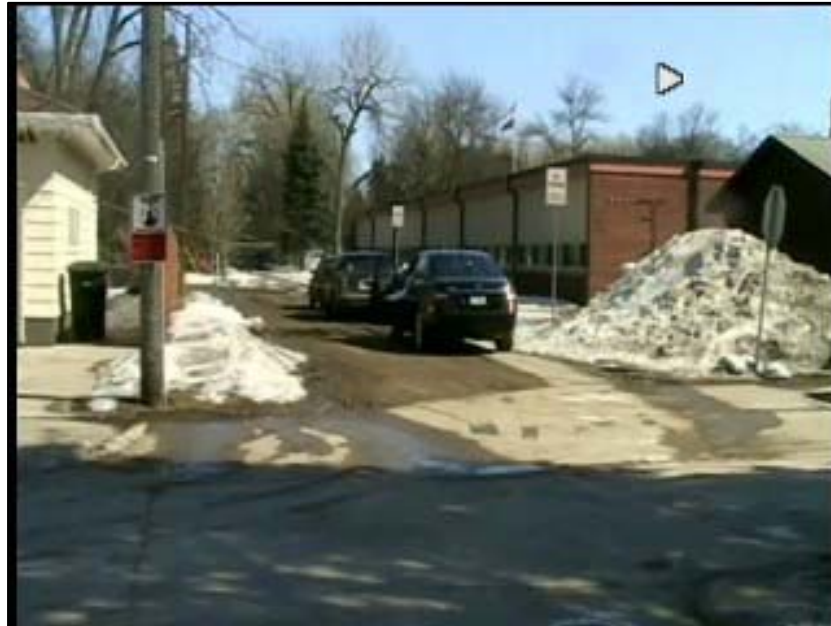
Several vehicles were parked along Columbia Ct., and the unpaved alley to the north of the school during dismissal. Traffic entering the unpaved alley from the west parked along the north side of the school, and after picking up the students, continued to the north. No observed issues occurred with the traffic movement on the north side of the school, although the alleyway was muddy due to melting snow (Figure 4.13).

Figure 4.13. Parking in the north alley during dismissal

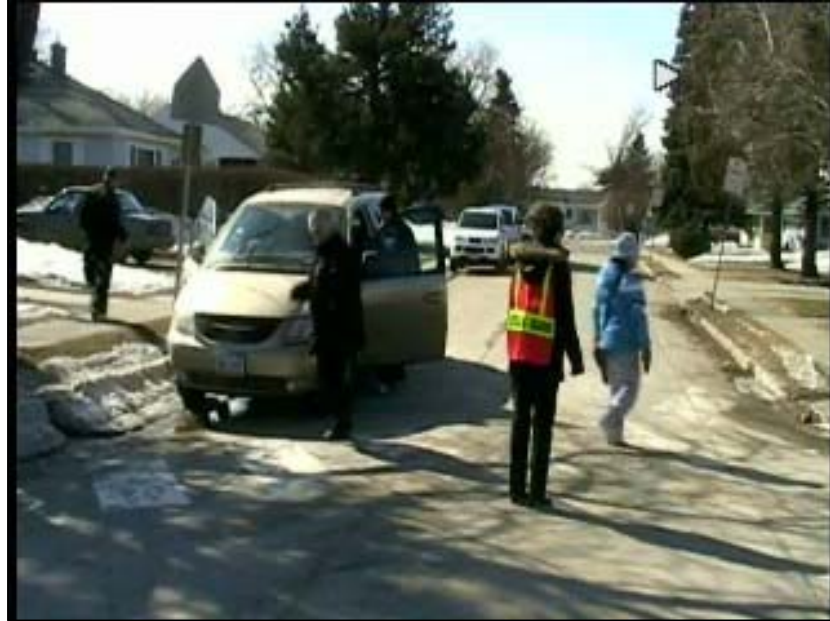
Several vehicles were parked along Columbia Ct., both to the west and north of the intersection. Upon dismissal, students used the crosswalks located at the intersection to get to the vehicles that were waiting for them. Two staff members served as crossing guards for the intersection of Columbia Ct. and the alleyways. The presence of crossing guards was beneficial to maintaining safe operations, and aiding in the visibility and awareness of pedestrians at the intersection, especially with vehicles parking in close proximity to the crossings (Figure 4.14).

Figure 4.14. Crossing guard at Columbia Ct.

Several crosswalks exist at the intersection of Columbia Ct. and alleys to the west and the north of the school. Two crosswalks are located on the west approach (Figure 5.4). One of the crosswalks is perpendicular to the road, and the second angles to the southeast. During the site visit and observation of the dismissal activity, it was noticed that only the angled crosswalk was used by pedestrians. Drivers appeared to disregard the second (perpendicular) crosswalk, and in several instances parked on it (Figure 4.14).

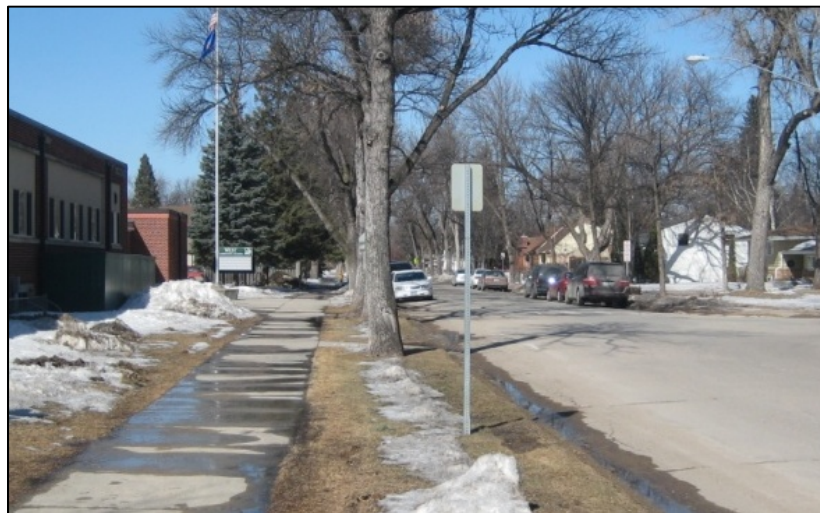
The operational characteristics on the east side of West Elementary School were also observed during the dismissal process. To the north of the school, several vehicles were parked along both sides of N. 25th St. In addition, a few vehicles were parked on the east side N. 25th St., across from the school (Figure 4.15).

Figure 4.15. Parking on N. 25th St. prior to dismissal

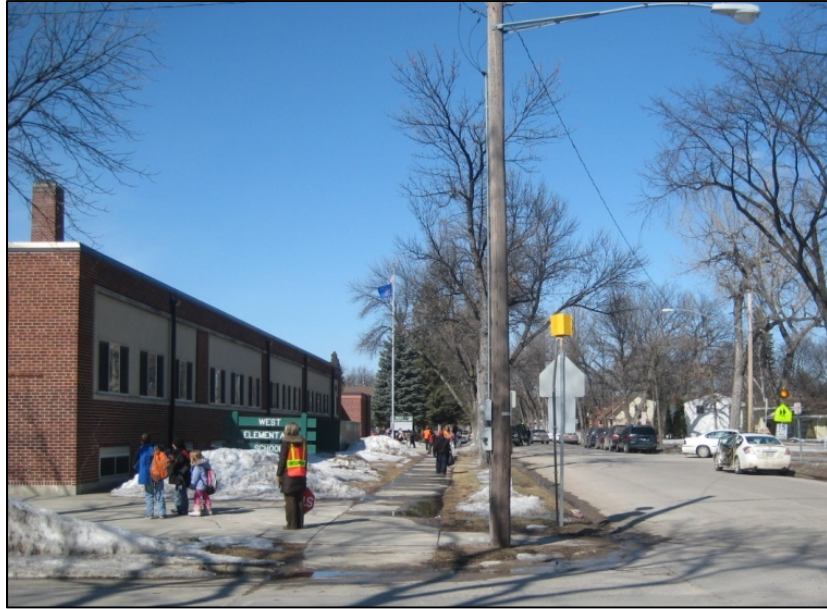
During school dismissal, the vehicle traffic increased slightly and the vehicles parking on both sides of N. 25th St. created a significant increase in congestion due to the narrowed roadway. Although the vehicle traffic increased, a few staff members were present as crossing guards to monitor the pedestrian activity. Crossing guards were located at both intersections of N. 25th St. and 6th Ave. N. (Figure 4.16). In addition, several pedestrian warning signs with flashing beacons were activated during the dismissal.

Figure 4.16. Crossing guards on N. 25th St.

Four pedestrian crossings exist on N. 25th St. to the east of the school. Although each crossing has an associated flashing beacon, the number of crossings is excessive. In addition, a flashing beacon is incorporated at alternating crosswalks. This is potentially a dangerous situation, as drivers' attention will be focused on the two crossings that they see the flashing beacons on, rather than all four. It is recommended that the south crossing on each intersection of 6th Ave. N. and N. 25th St. be eliminated, and the flashing beacons and signs be situated on both sides of a single crossing (one for each direction of oncoming traffic).

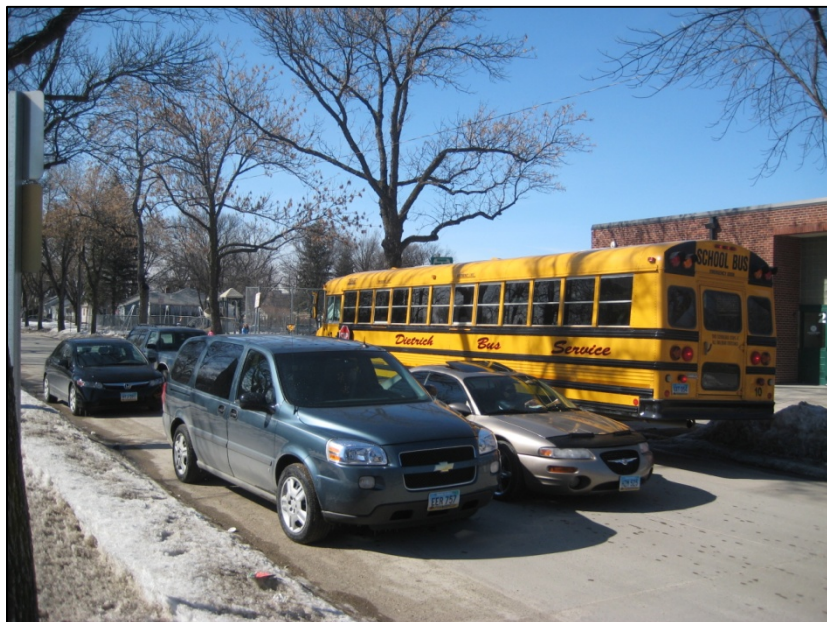
One school bus was observed at the school during the dismissal. The bus loading took place on 6th Ave. N. on the south side of the school. The presence of the bus caused the street to be temporarily restricted to one lane (Figure 4.17).

Figure 4.17. Bus loading on 6th Ave. N.

During the initial stakeholder meeting, the location of the bus loading area was indicated as being on the east side of the school on N. 25th St. However, during the site visit the bus loading was observed along the south side of the school on 6th Ave. N. (Figure 4.17). It is recommended that the bus loading be located on the east side of the school (using signs and curb markings), adjacent to the main doors on the north side of the intersection of 6th Ave. N. and N. 25th St. This location provides the most ideal safety conditions with regard to pedestrians and passing vehicles.

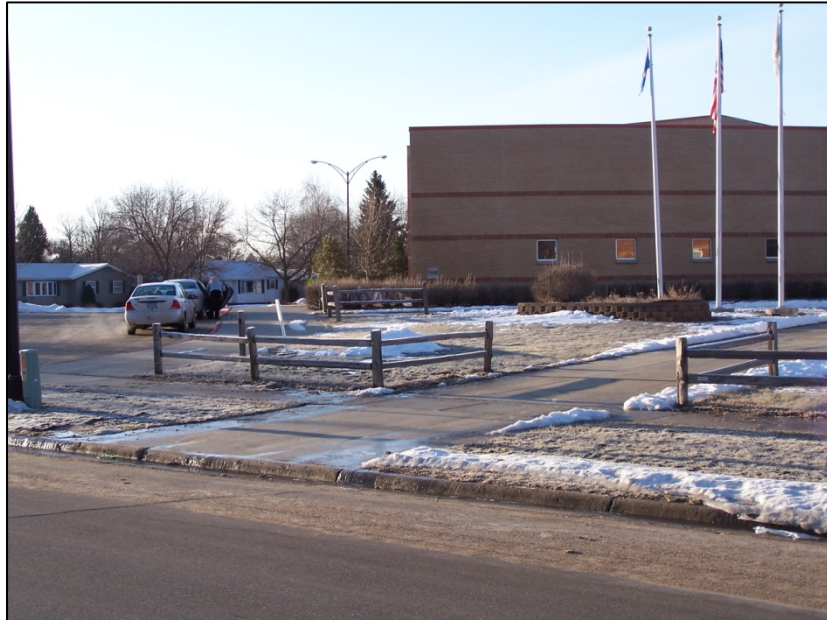
Prior to the school start time, several teachers were observed parking along both sides of 15th St. NW., directly north of the school. Parents were observed dropping off their children via the drive-through on the north side of the school (Figure 4.18).

Figure 4.18. Early arrivals on the north side of the school

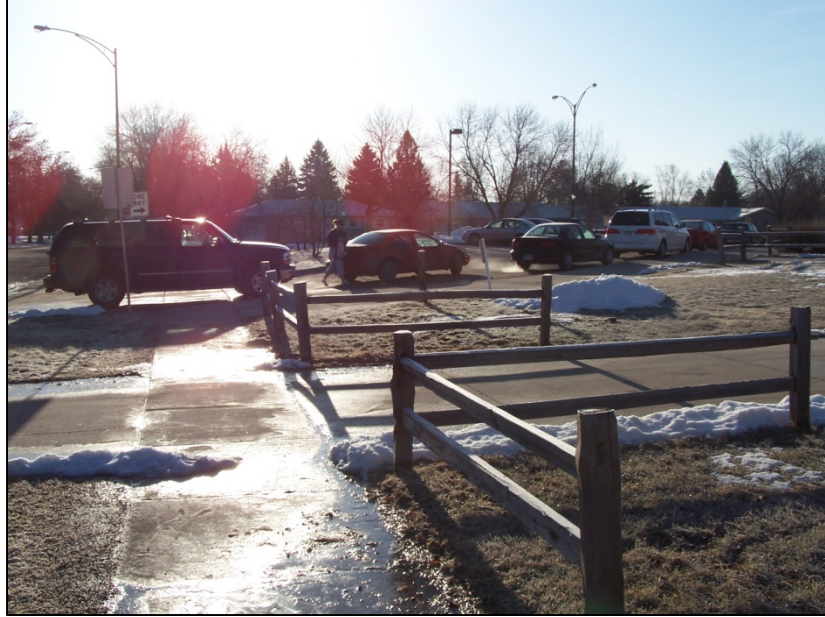
As more parents began dropping off their children, operational deficiencies began to emerge. The operational issues that were observed in the drive-through area were a result of parents parking and leaving their vehicles unattended. During the peak period, parents were parking three-wide in the drive-through, thereby blocking vehicles behind them. In addition, parents were observed parking in the approach, which blocked the sidewalk (Figure 4.19). As a result of the congestion in the drive-through, some spillback was observed on 15th St. NW. due to vehicles waiting to turn into the drive-through. On one occasion, drivers were observed honking at each other in frustration of being boxed in. In addition to using the drive-through, several parents were observed parking along 15th St. NW. and walking their children into the school (Figure 4.20).

Figure 4.19. Parking in the drive-through

During the morning drop-off period, the drive-through area on the north side of the school saw a fairly significant amount of traffic. A couple of issues were noticed with parents double and triple-parking, and exiting their cars. In addition, parents were observed parking in the approach to the drive-through and blocking the sidewalk. In order to maintain efficient operations in the drive-through, parents should be reminded to not block the driving lane. In addition, it is recommended that the sidewalk be outlined at the entrance and exit of the drive-through to increase the visibility, and to remind parents that parking on a sidewalk is unacceptable. Another option to alleviate the congestion on the north side of the school is to encourage more parents to drop off their children on the south side of the school, and instruct school faculty/staff to park on 8th Ave. NW. and the west end of 15th St. NW. This would free-up a significant amount of curb space on the east end of 15th St. NW., particularly around the entrance to the drive-through area. It was observed during the site visit that the operations on the south side were much smoother than the north side due to a significantly fewer number of parents using the south side.

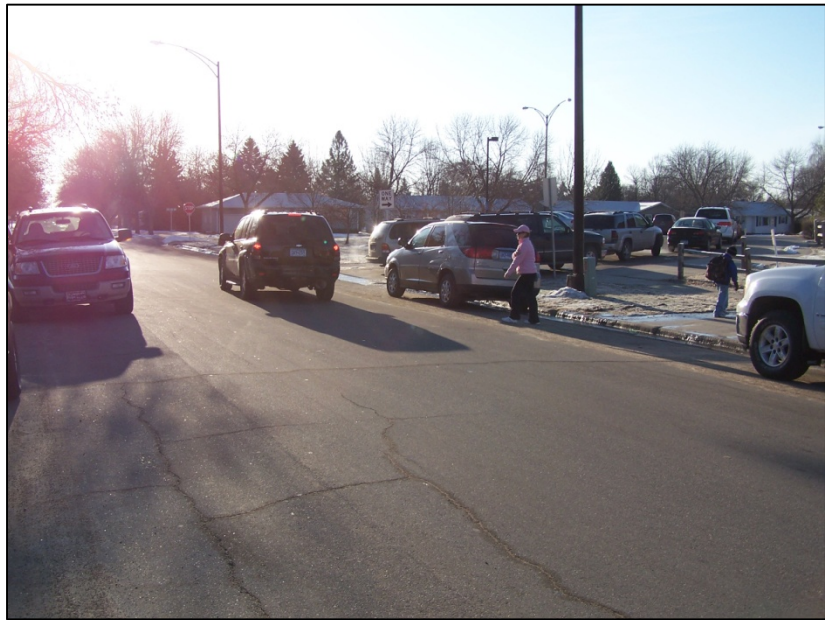
Figure 4.20. Parking along 15th St. NW.

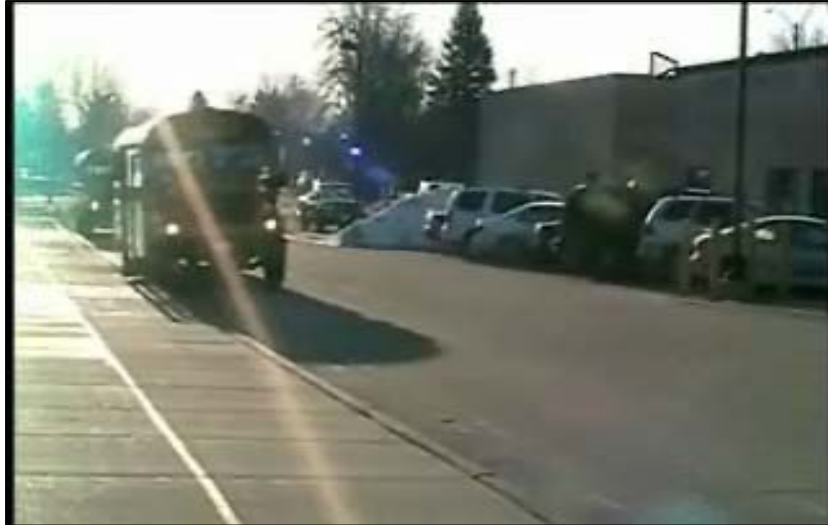
The arrival process on the south side of the school was relatively efficient, and no issues were observed. The primary activity on the south side consisted of busses unloading students (Figure 4.21). In addition, several parents dropped off their children at the south door.

Figure 4.21. Bus unloading on the south side of the school

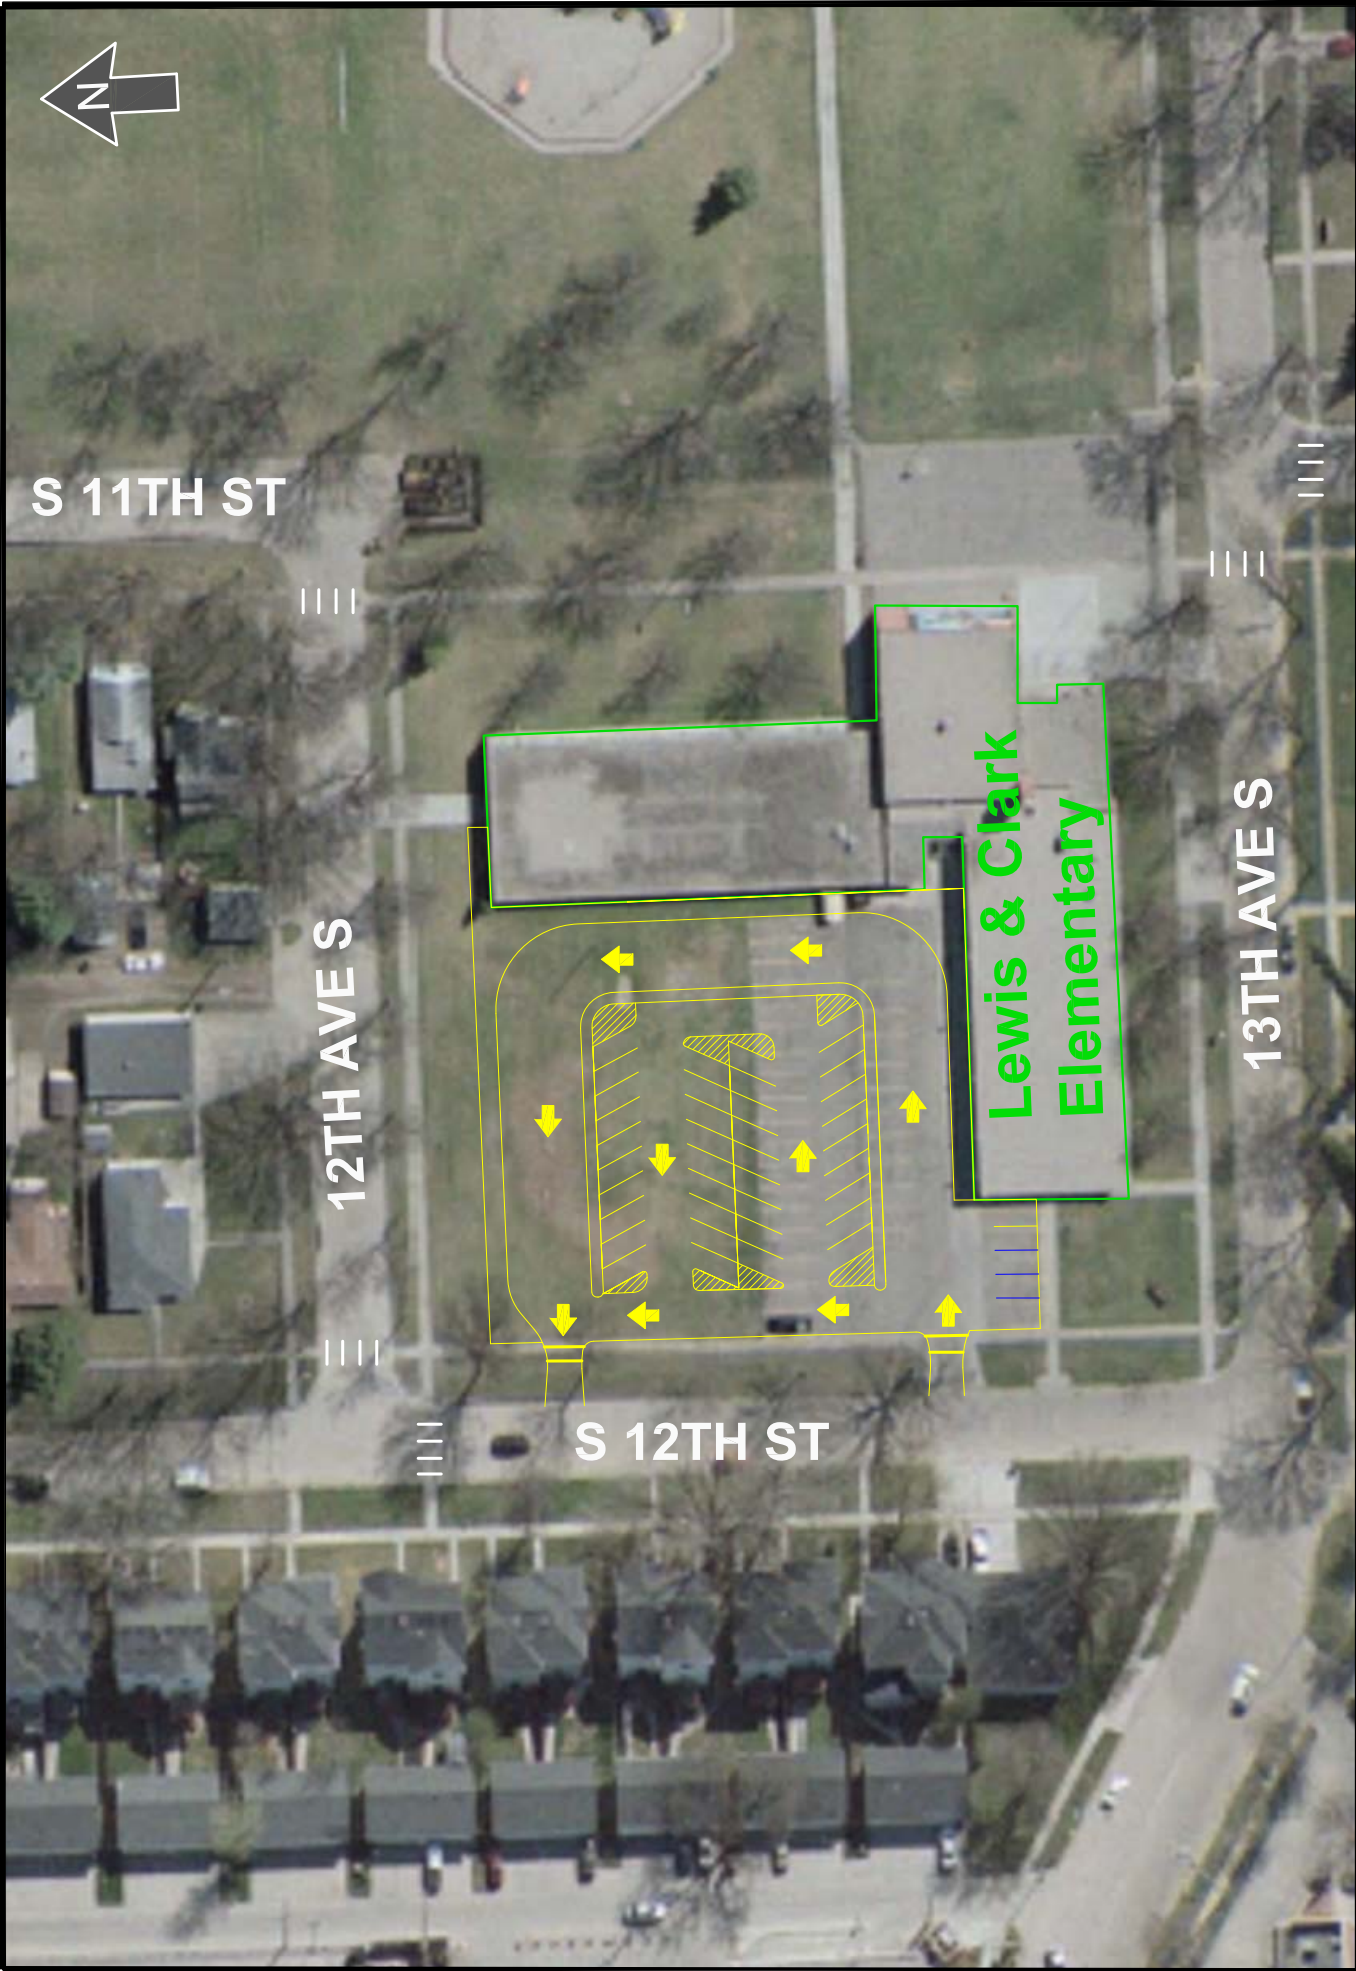
Figure 5.2

Due to the location and boundaries of the school, limitations exist related to potential geometric changes. After analyzing the data and looking at various alternatives, two geometric changes can be incorporated at the school (Figure 5.2). First, the staff parking lot can be expanded to increase capacity. Increasing the capacity will free up the parking space along the streets, which is currently being used by staff members. Along with the expansion of the parking lot, a second driveway was added to provide better access. To keep vehicle flow uniform in the parking lot, the driveways utilize one-way operations. A second geometric change is to provide a drive-through area around the perimeter of the staff parking lot, with a raised curb to separate the parking lot from the drive-through. This would provide a loading and unloading area for parents, and would alleviate the parking on 12th Ave. S. The cost estimates for implementing the long-term strategies range from \$189,400 to \$247,100 (Table 5.1).

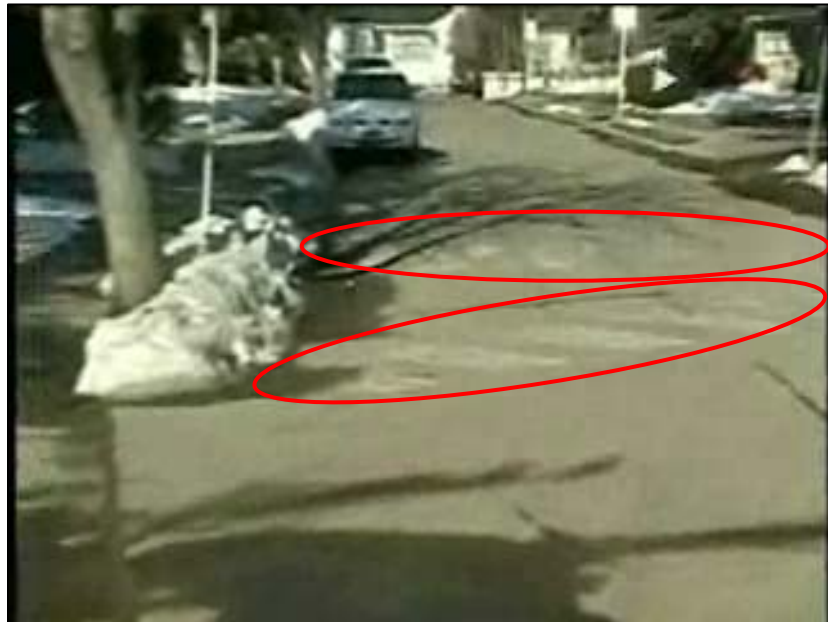
Figure 5.4. Multiple crosswalks on Columbia Ct.
