School Safety Study for Lewis & Clark, West, and New Heights Elementary Schools

Final Report

Prepared for:
Grand Forks – East Grand Forks Metropolitan
Planning Organization

Prepared by:
Advanced Traffic Analysis Center
Upper Great Plains Transportation Institute
North Dakota State University
Fargo, North Dakota

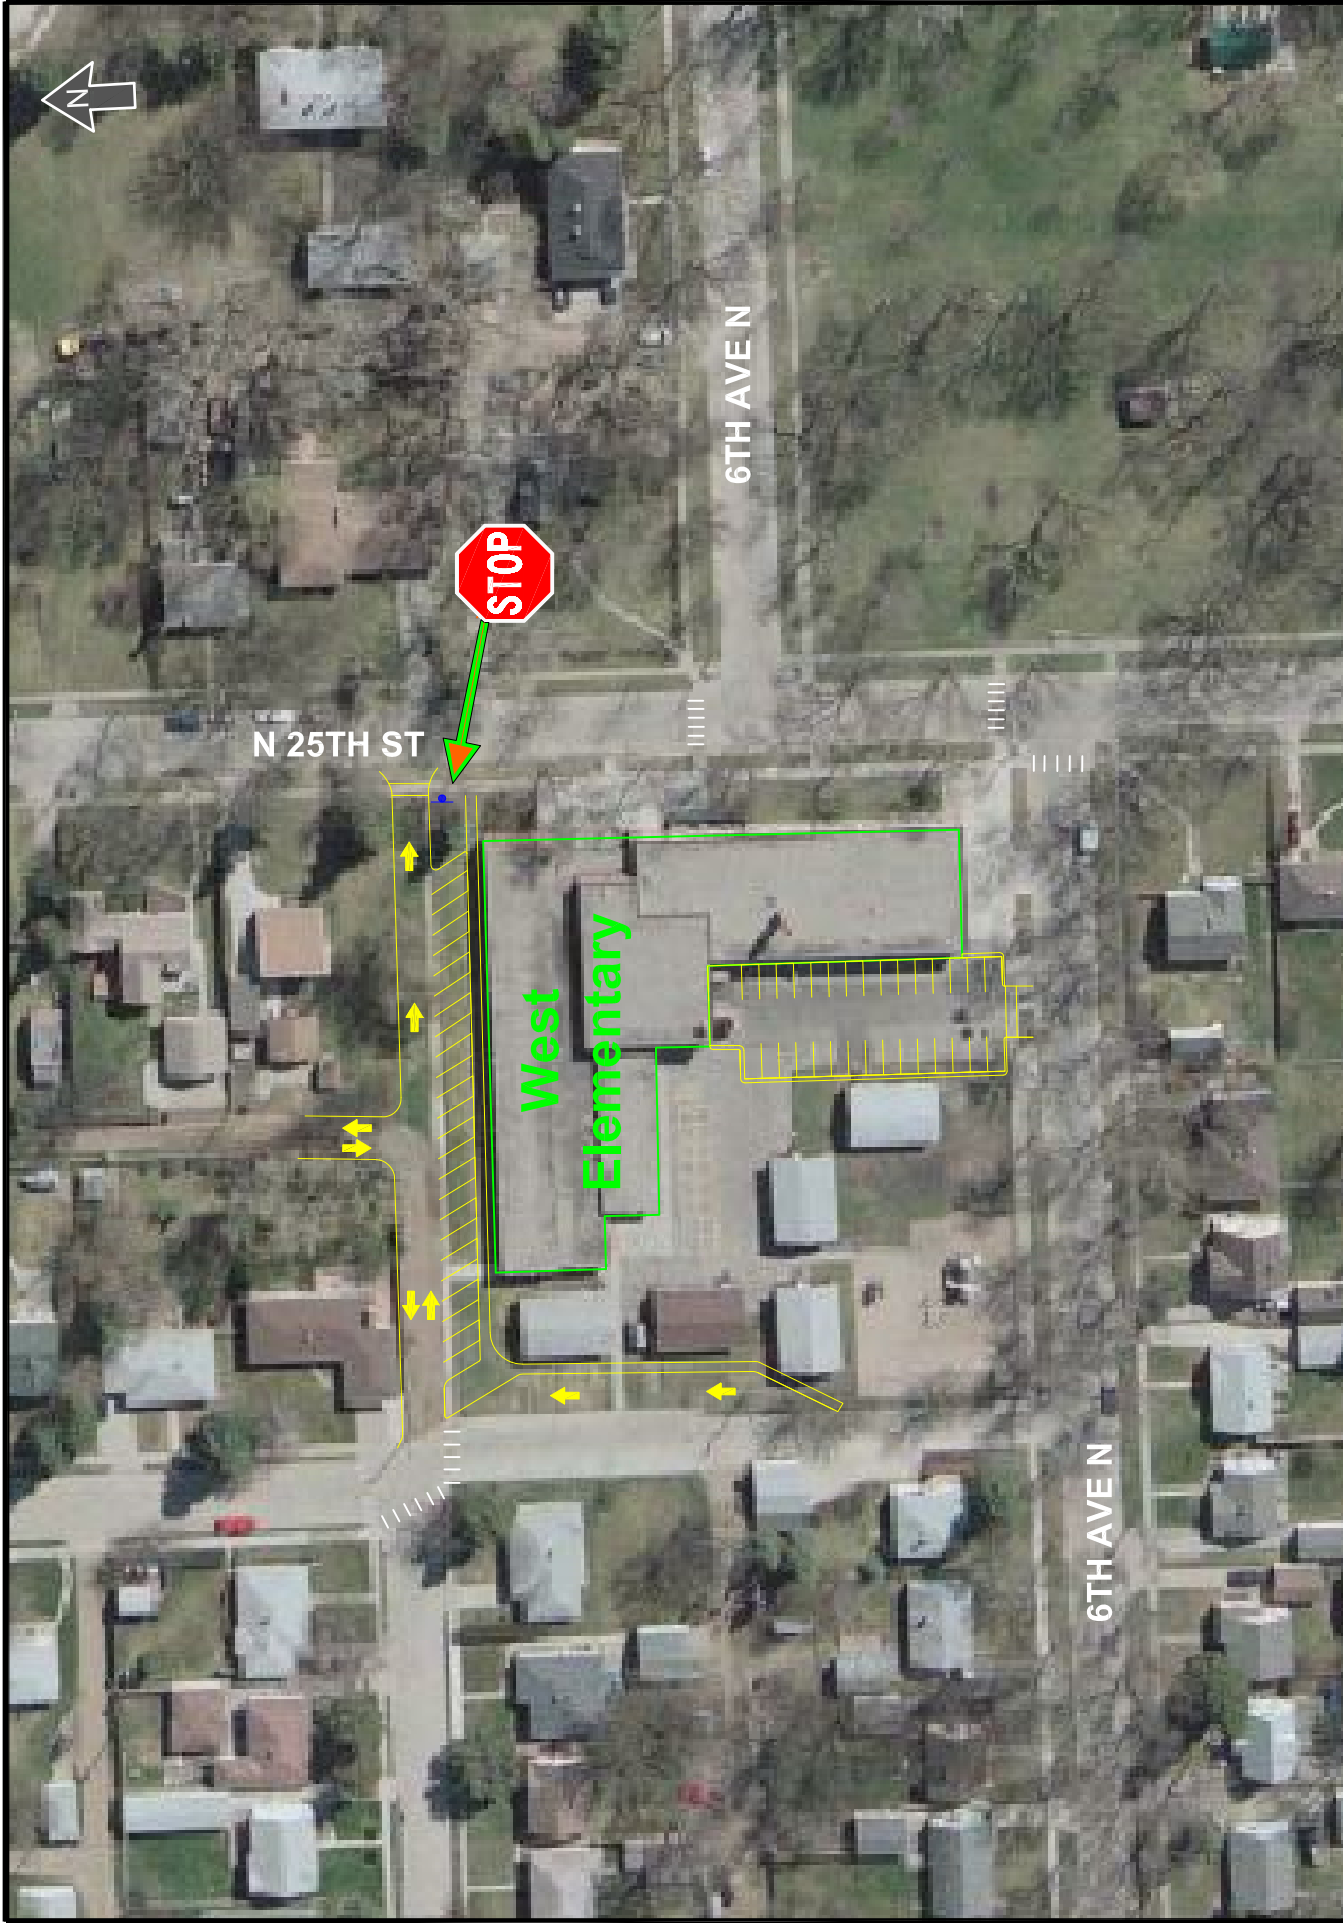
The proposed geometrical enhancements are primarily related to the movement and accessibility of vehicles around the school, thereby improving the safety for students. The first recommendation is to increase the capacity of the staff parking lot on the south side of the school. (Figure 5.5) According to school officials, the current parking lot capacity is insufficient for the number of staff at the school, and the overflow parking for staff is scattered among the surrounding streets. Expanding the parking lot to the west will provide sufficient parking for all staff, which will improve the parking capacity in the streets. In addition, adding a curb/border to the parking lot will help in maintaining a separation between the parking lot and the adjacent playground (which shares the same paved area).

The second recommendation addresses the issues observed in the west alley and the north side of the school. Since the school property extends to include the east-west portion of the unpaved alley on the north side of the school, it is recommended that the alley be paved, and a one-way access road be constructed along the north side of the school. This extension will provide additional access to N. 25th St., and will serve as an alternative to the alleyway which extends to the north. The one-way operation will help to maintain efficient traffic flow around the school. In addition, diagonal parking is proposed along the north side of the school, accessed by the new roadway. This will provide additional parking for school faculty and staff. A bus turn-out lane was also added to the alleyway on the west side of the school. The re-location of the bus loading to the west side of the school creates a safer environment for students, as the busses are removed from surrounding roadways. Cost estimates for each of the long-term recommendations range from \$16,100 to \$78,900 (Table 5.2).

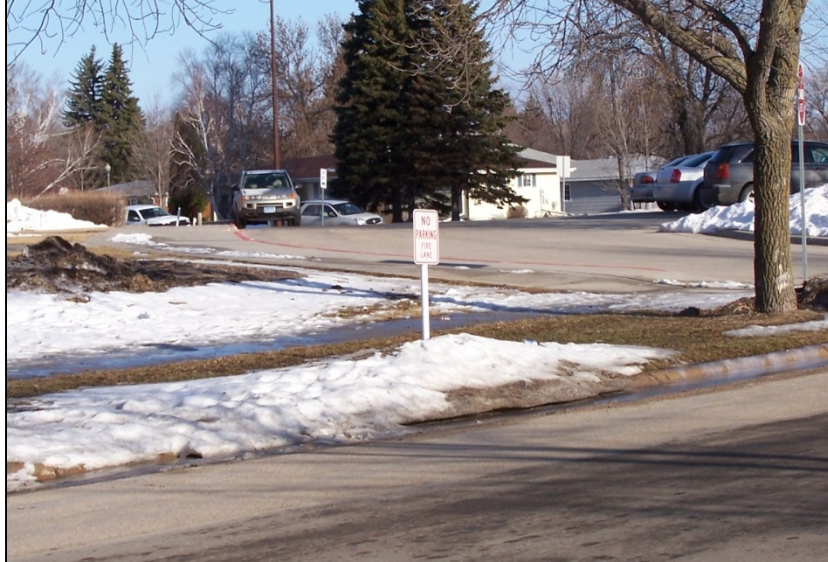
As mentioned previously, two parking restrictions were in place at the school. Both signs were “no parking fire lane” signs, and were located on the north side of the school (Figure 5.7). However, the signs appeared to be mounted on a temporary/portable base. It is recommended that the signs be placed permanently, and be replaced with “no parking loading and unloading only” signs. The approximate cost for updating the signs and pavement markings is \$4,900.

Figure 5.7. Parking restriction at New Heights Elementary
