# *Near Southside Historical Neighborhood Traffic Study*

Final Report

May 2018

Prepared by:  
Advanced Traffic Analysis Center  
Upper Great Plains Transportation Institute  
North Dakota State University  
Fargo, North Dakota

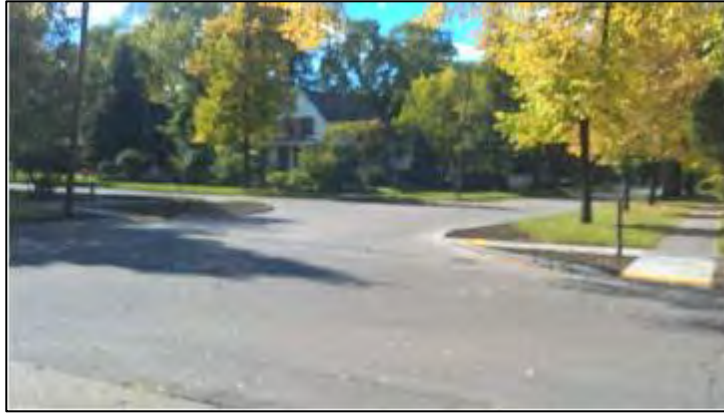
**Figure 9. Reeves/4<sup>th</sup> curb extension**

During the months of July and August, the neighborhood and city agreed to make the temporary traffic calming techniques more permanent. Concrete was poured to take the place of the bollards and traffic barricades. Curbs were installed and dirt with grass seed was installed where previous driving pavement existed behind the new curbs.

As seen in figures 9 and 10, the turning radius at the intersection was greatly reduced. Before, a vehicle could make the turning movements at a higher speed due in part to the allowance of a large turning radius. The reduction in radius was done on all sides of the intersection. This resulted in a much tighter space to make the movements necessary to continue through traffic movements. The stop condition was also enhanced by placement of the stop sign closer to the intersection.

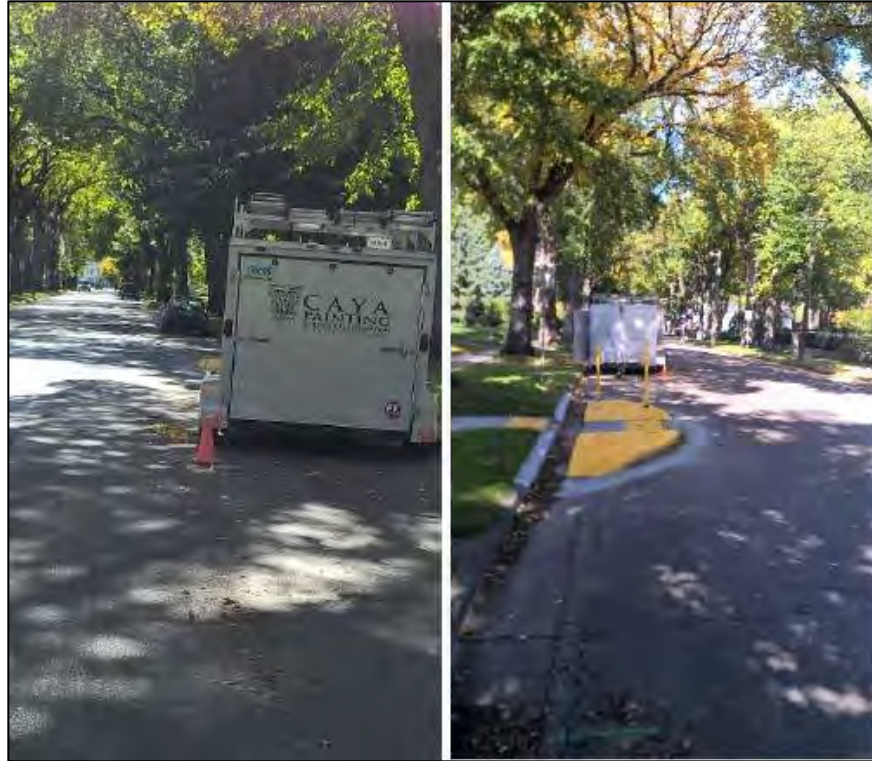
**Figure 12. Reeves Drive bulb-out**

The photo on the left shows the installation partially hidden by a work trailer. The view is looking southbound on Reeves. The trailer makes a more imposing impediment to the traffic than the curb bulb-out. The photo on the right reveals more detail about the curb bulb-out permanent installation.

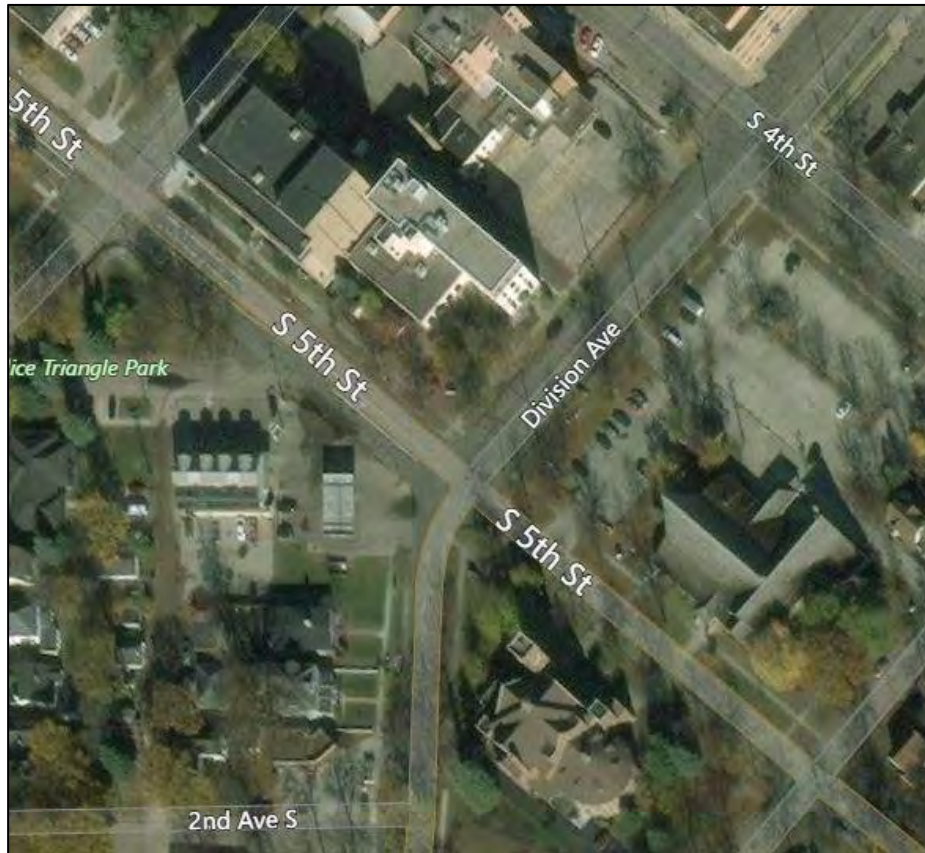
**Figure 19. Belmont/5<sup>th</sup>/Division intersection**

The Belmont/5<sup>th</sup>/Division intersection has unusual approaches from the adjoining streets intersecting at this location. This intersection is on an edge of how the street network transitions from being orientated with the Red River to being orientated with the geological survey grid system. 5<sup>th</sup> St. and Division reference the river; whereas, Belmont Road is based upon the grid. Figure 19 shows the unusual intersection.

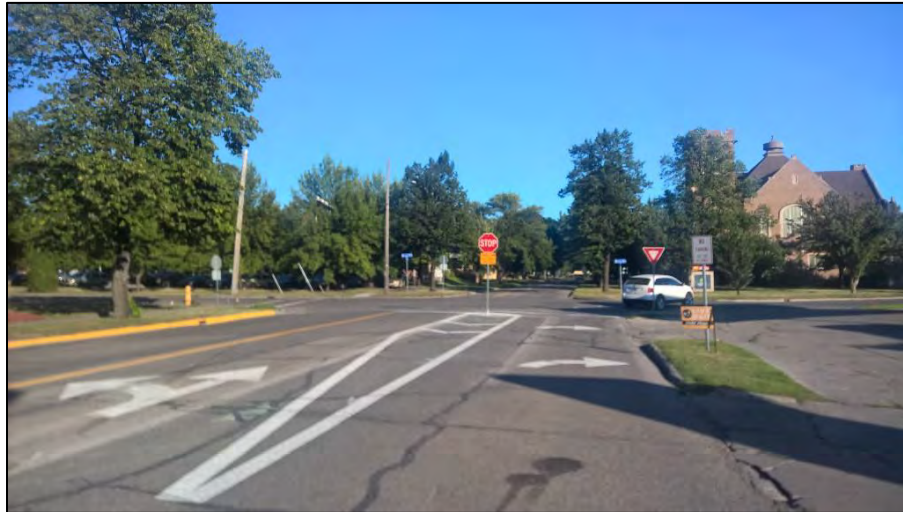
Figure 22. Belmont/5<sup>th</sup>/Division SB approach

This strategy was later augmented with the conversion of the southbound approach from 5<sup>th</sup> St. having the left turn lane and the through lane combined into one lane at the usual location of a left turn lane. The former space that was used for the through lane was striped to shift traffic away from the space so that a stop sign could be installed “in the middle of the street”. Hence, the left turn and through movements are controlled by the stop sign. The City installed a yield sign for the right turning movements so that they are directed to yield to traffic from Division Ave passing through the intersection.

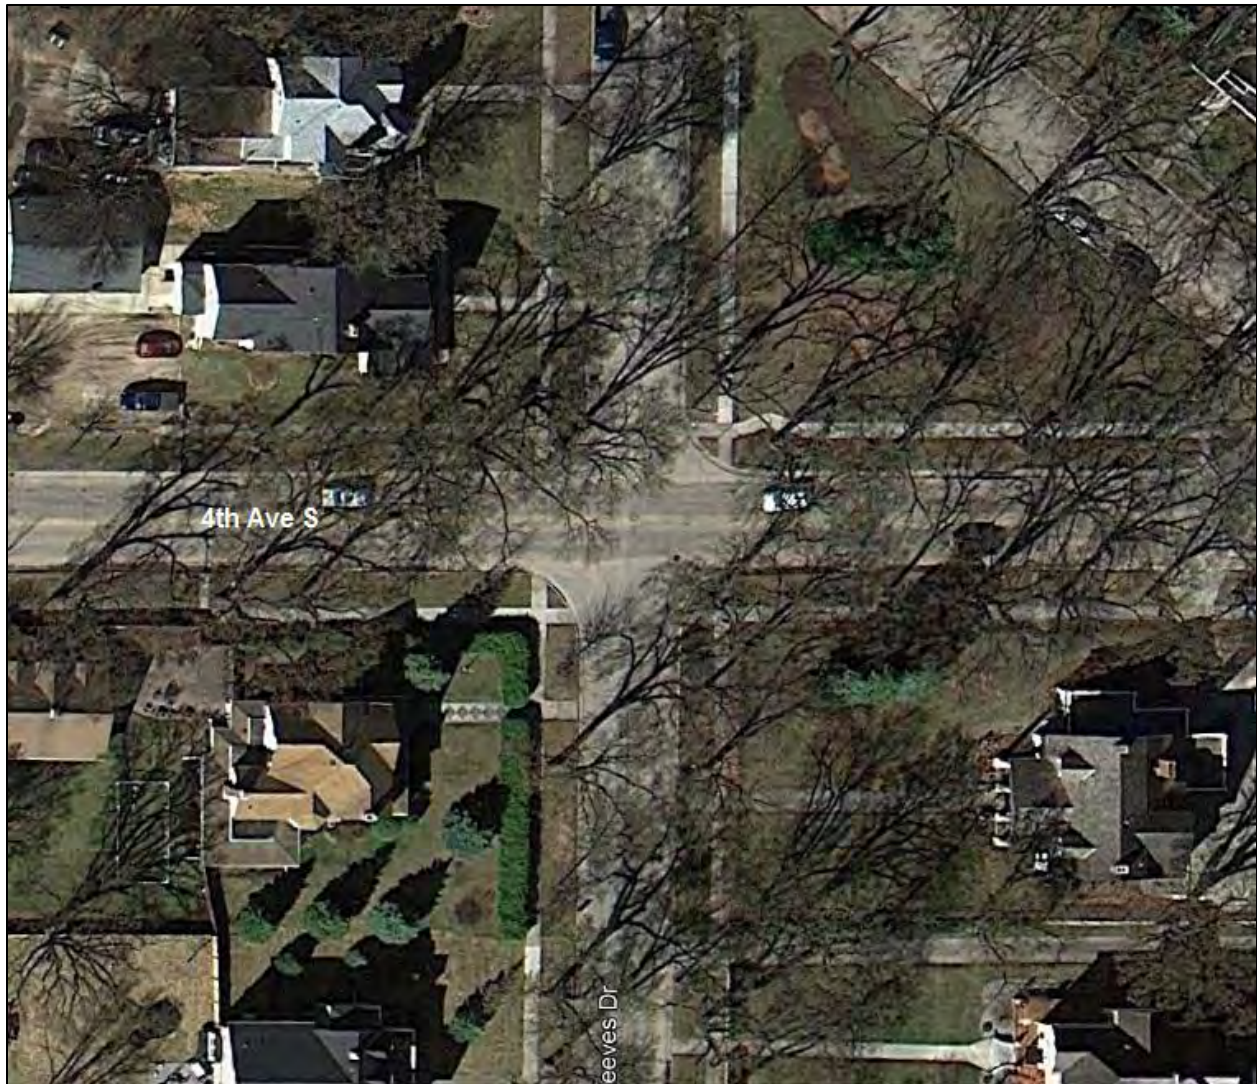
**Figure 25. Reeves and 4<sup>th</sup>**

Reeves Drive is a paved, two-lane north/south local street, posted as 25 mph. The pavement width is 30 ft. and parking is permitted on the southbound lane and restricted only on Mondays from 8am to 4pm for the northbound lane. At the 4<sup>th</sup> Ave. intersection, north and south traffic is restricted by two-way stop control signs.

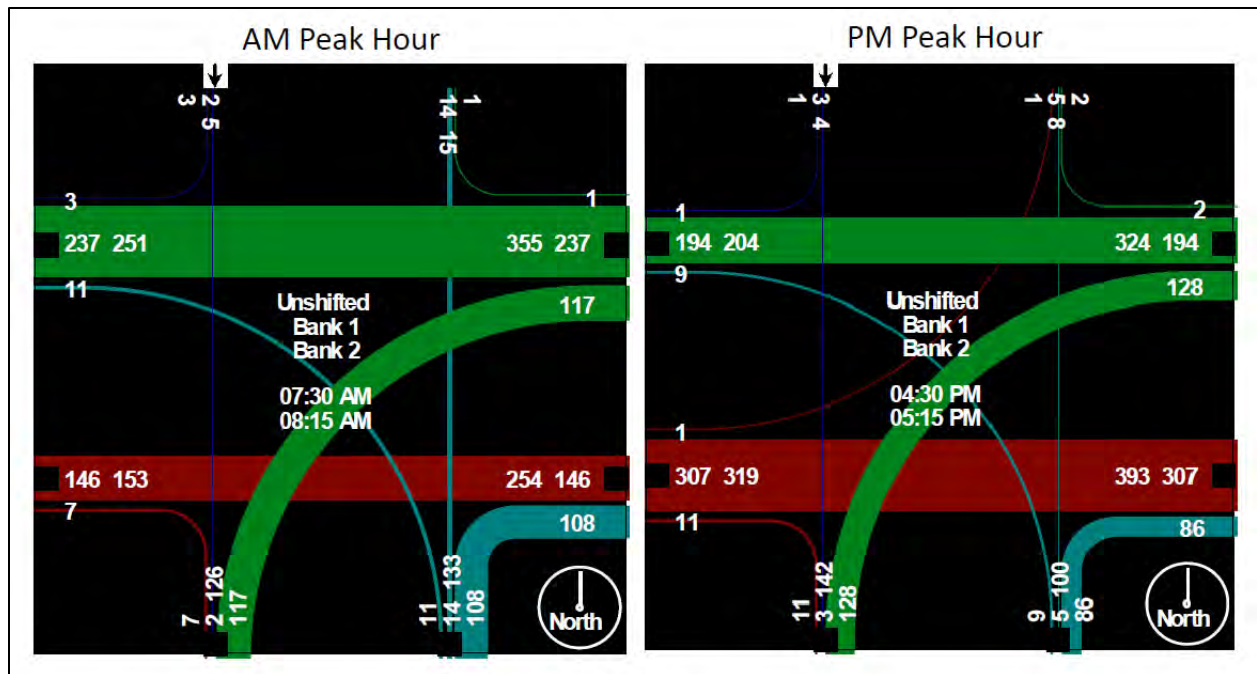
Figure 26. Reeves and 4th turning movements

Local residents have expressed great concern for cut-through traffic along Reeves Drive. Follow-up turning movement counts at Reeves and 4<sup>th</sup> Ave. and Reeves Dr. and 8<sup>th</sup> Ave. proved that cut-through traffic is an issue. Similarly to the Belmont and 4<sup>th</sup> Ave., peak hour traffic volumes appear to peaking slightly more in the pm than the am.. This may be due to the nearby one-way streets forcing drivers to take different paths in the am vs. pm.

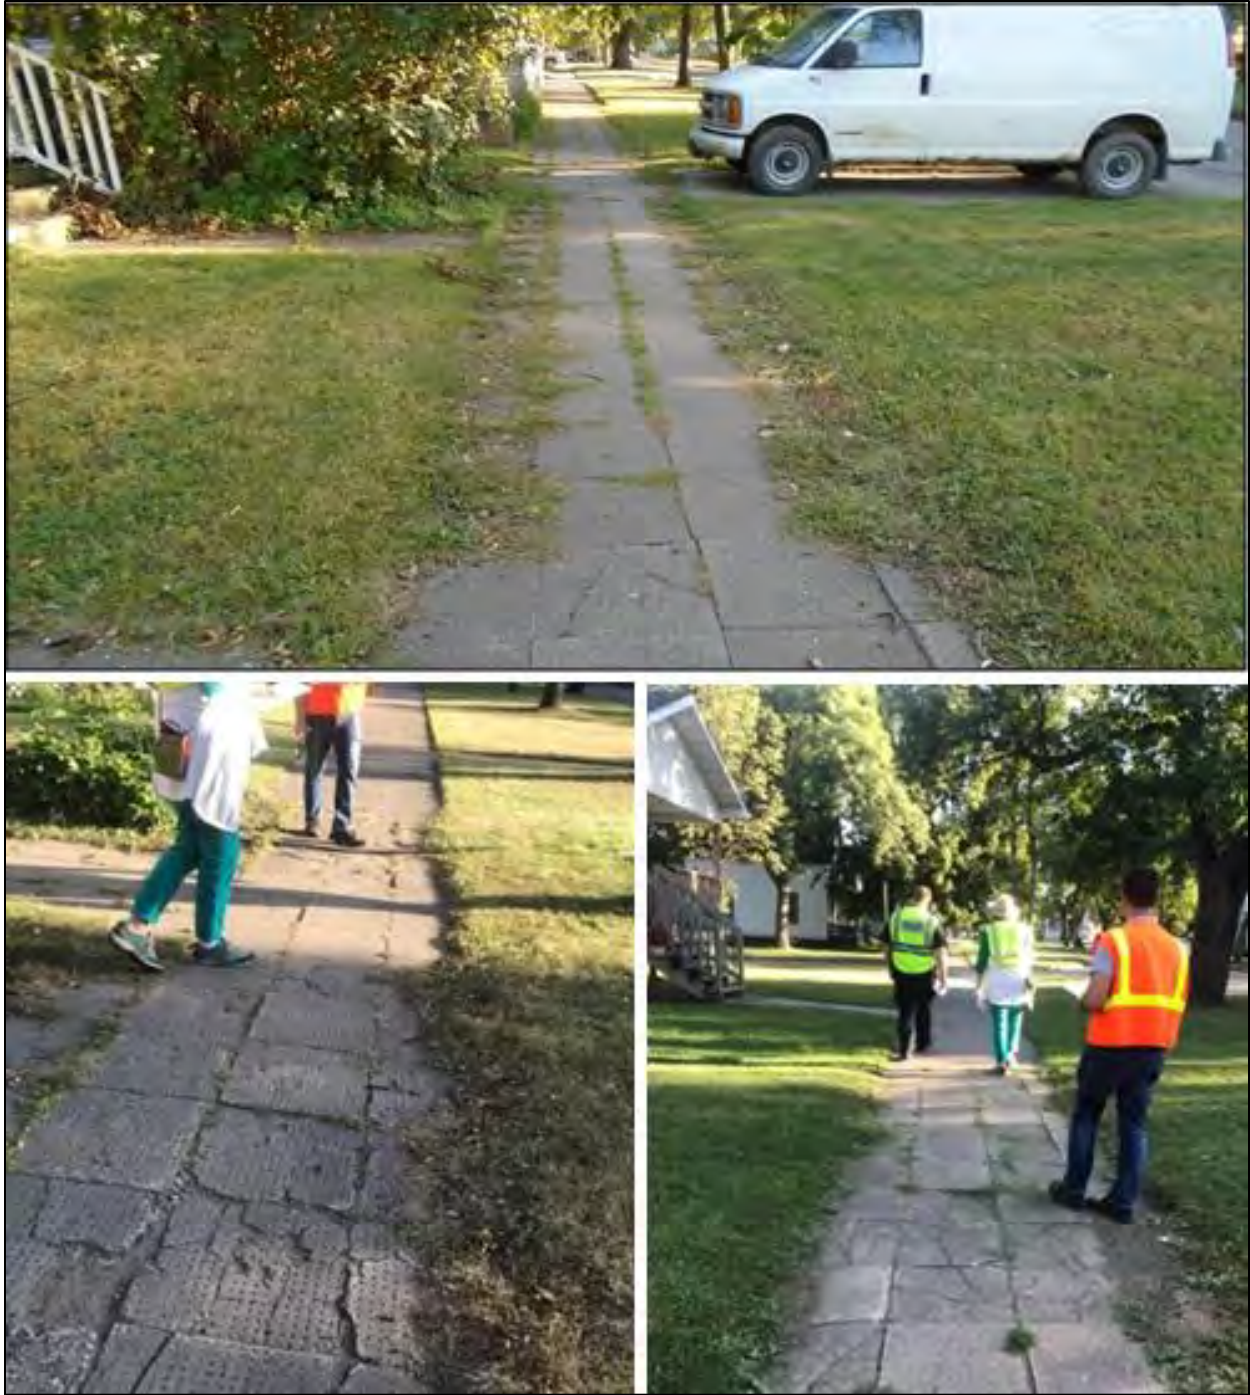
**Figure 28. Sidewalk quality**

For the assessment, sidewalk quality had the most negative impact towards the overall score. Throughout the study area there were repeated reports of the sidewalks being broken, cracked, or discontinuous, and being obstructed by objects or shrubbery.

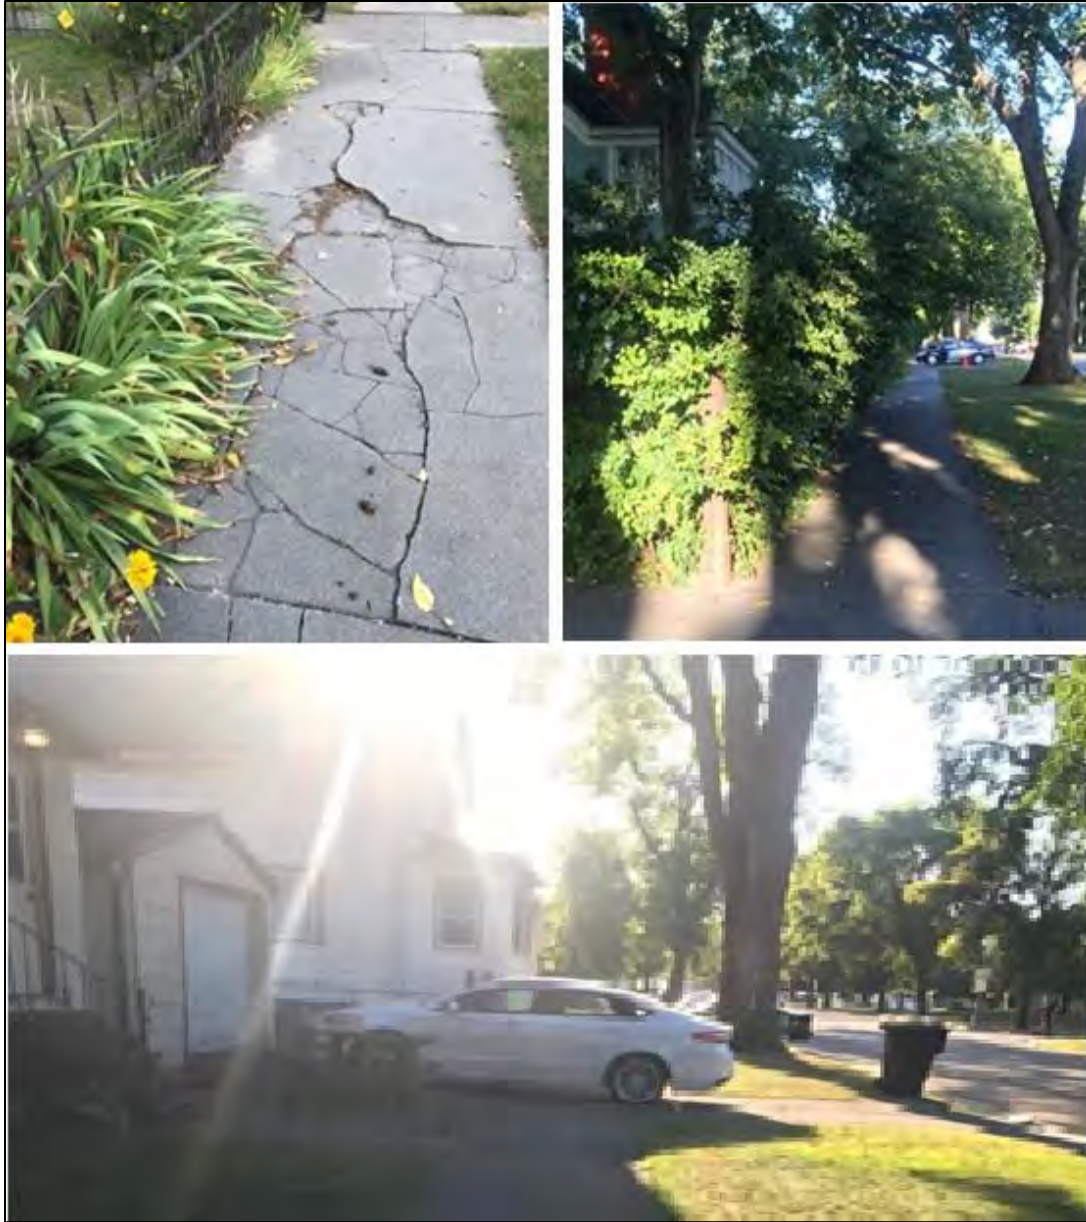
**Figure 30. Sidewalk obstructions**

Figure 31 shows sidewalks in the neighborhood that are unsafe due to tripping or slipping hazards. These areas may be dangerous, especially when walking at night.

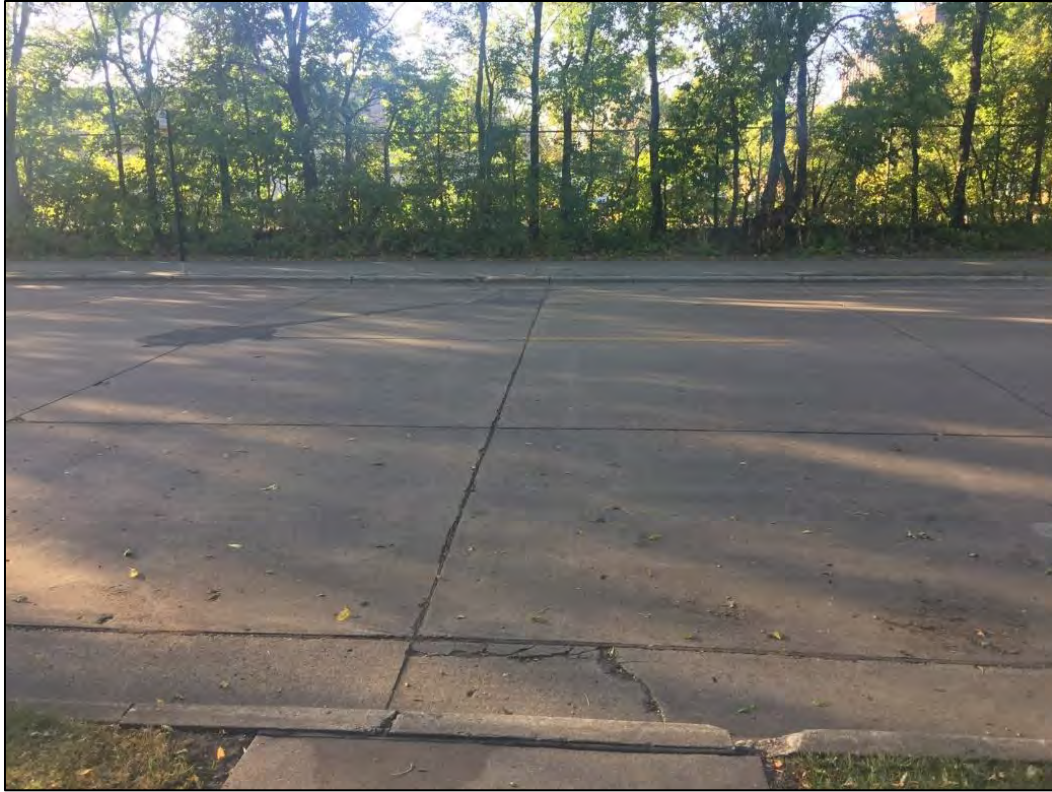
**Figure 32. 1st Ave. bus stop**

One serious pedestrian safety issue is at the bus stop on the north side of 1<sup>st</sup> Ave. S. between Cherry and Cottonwood streets as seen in Figure 34. With all trip origins/destinations on the south side of the street, pedestrians are forced to cross 1<sup>st</sup> Ave. at this bus stop location. As seen in Figure 34, there are no ramps and the location lacks a marked crosswalk. This presents a potentially dangerous situation as the traffic along 1<sup>st</sup> Ave. receives no warning that there may be pedestrians crossing the street.

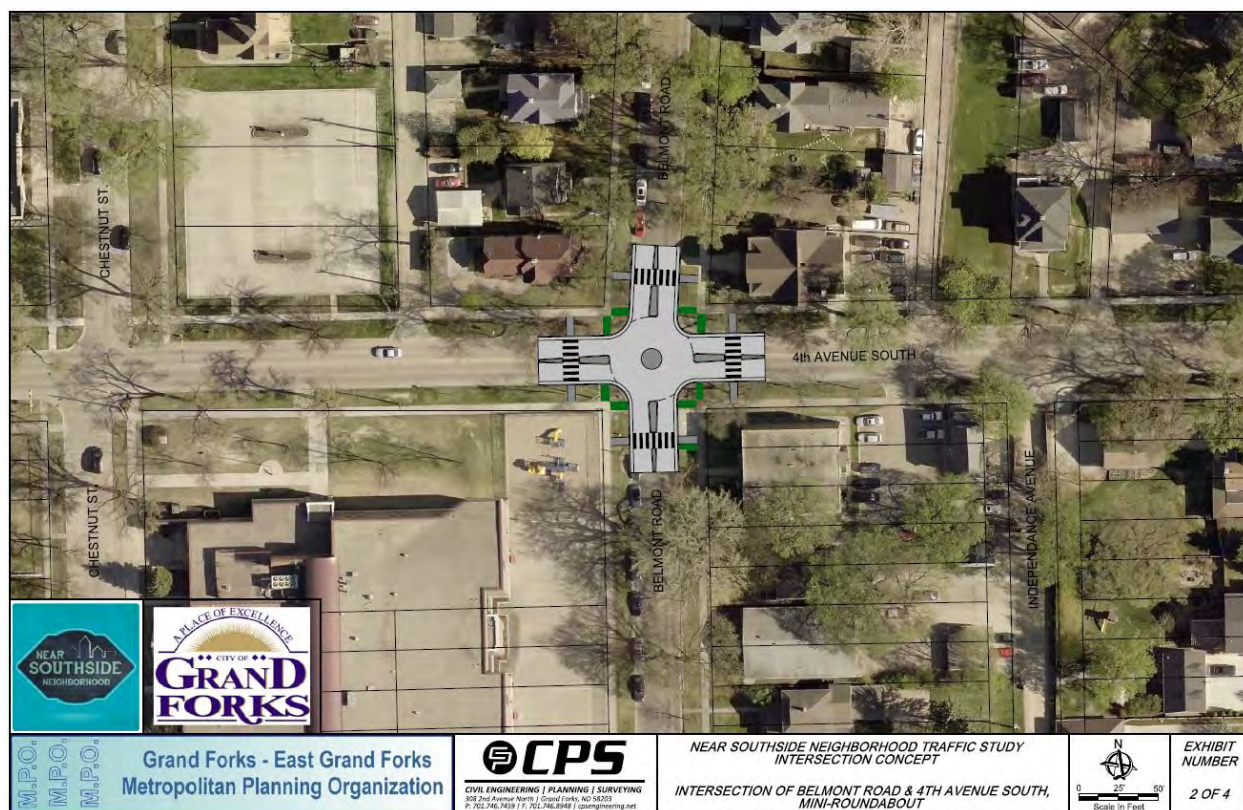
Figure 42. Belmont and 4th concept

With proper design, a roundabout could be a focal point where school buses, passenger cars, pedestrians such as school children, and bicycles are able to share the road safely. In the United States, roundabouts near school zones are slowly increasing in number.

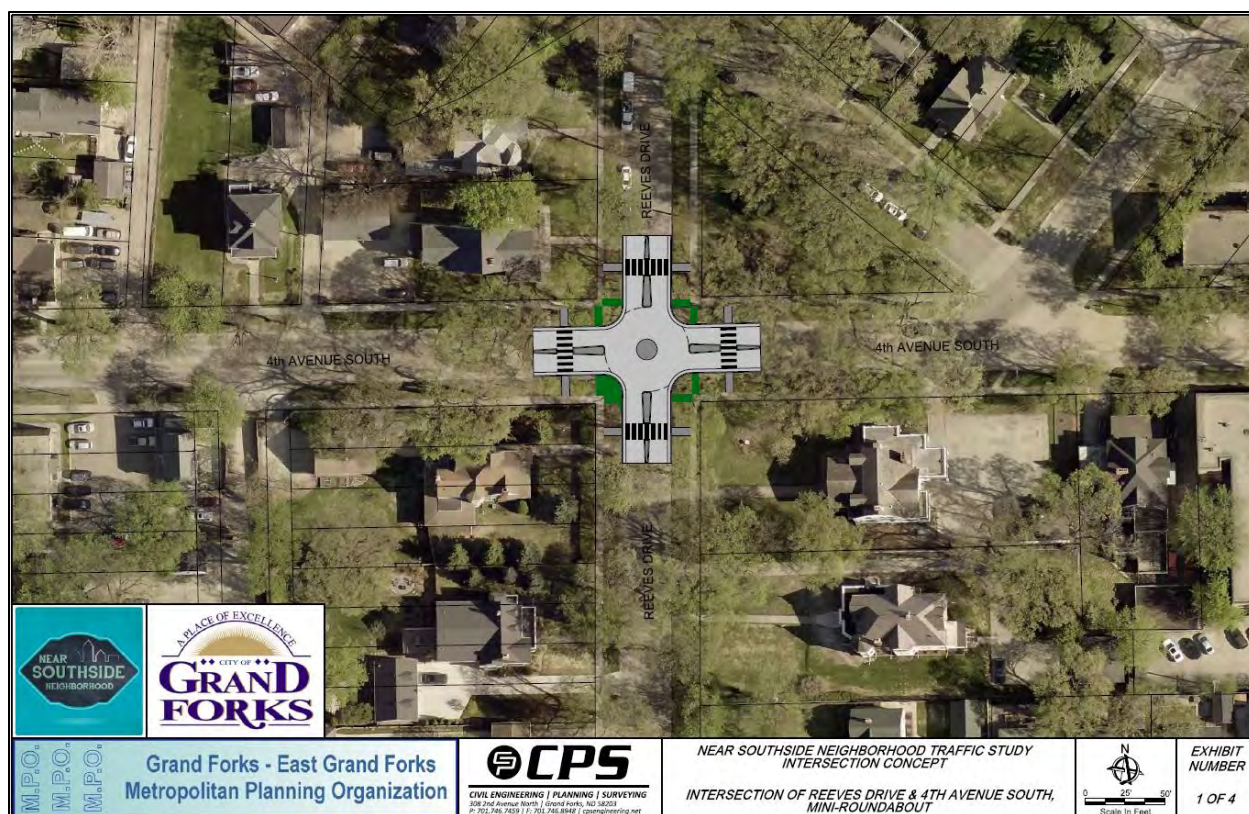
Figure 43. Reeves and 4th concept

The mini roundabout at this intersection takes on the same benefits and operational impacts as previously stated. For this intersection in particular, a mini roundabout at this location would calm westbound traffic coming from Point Bridge entering both the intersection and school zone. This is beneficial to not only reduce speeds at the intersection, but also optimize school speed zone compliance west of the intersection. A reduction in angle crashes is expected to be nearly eliminated at this intersection where angle crashes is a current problem. East and west traffic would maintain free flow traffic and improve the traffic flow along the arterial corridor. This benefit is expected to reduce cut-through traffic on Reeves Drive.

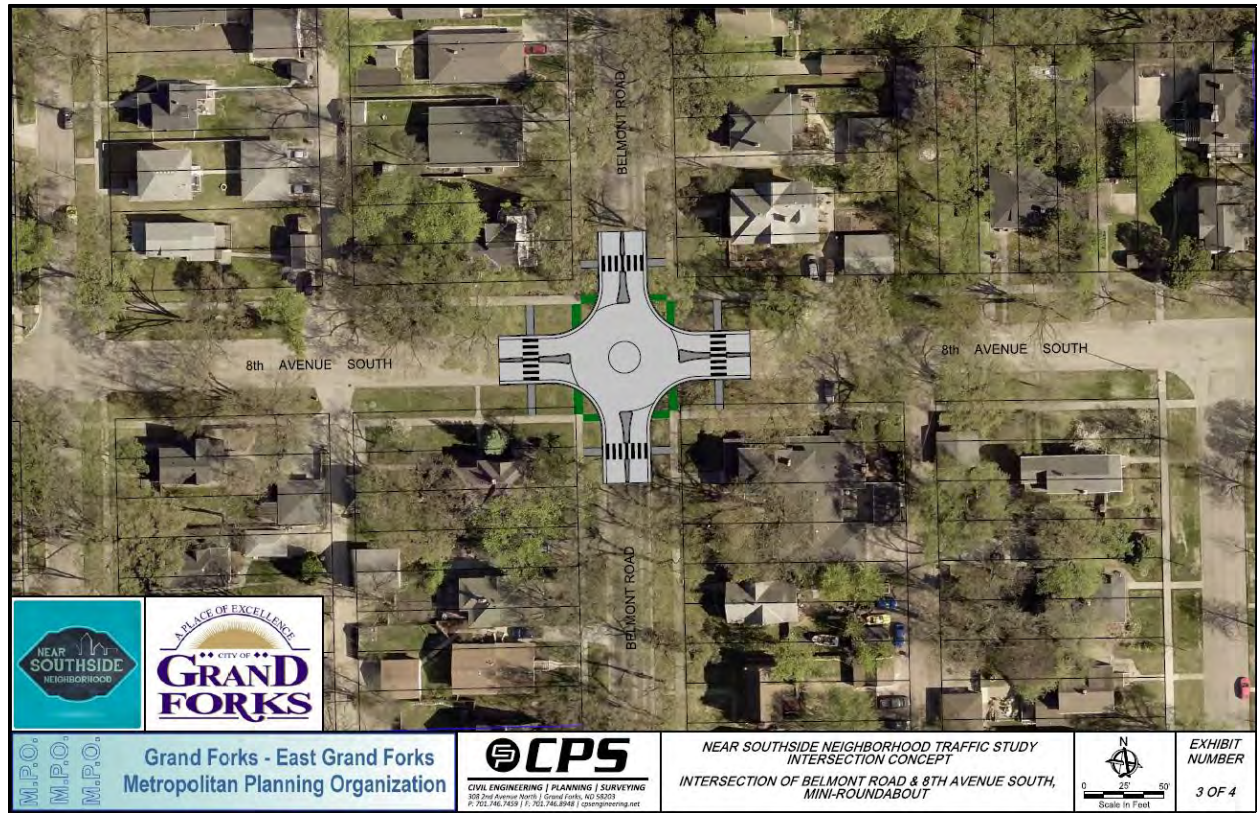
Figure 44. Belmont and 8th concept

Though this intersection does not experience a high number of crashes relative to the other intersections, this section of roadway desires calmer traffic speeds with improved traffic flow. Improving the traffic flow at this intersection encourages traffic along Belmont to not cut through to Reeves Drive. Residents near this intersection also expressed concern of vehicles “drag racing” once stopped at this intersection. The mini roundabout should eliminate this action as well as reduce any noise pollution caused by vehicles stopped and starting at the stop sign. Figure 46 shows the concept for this intersection.

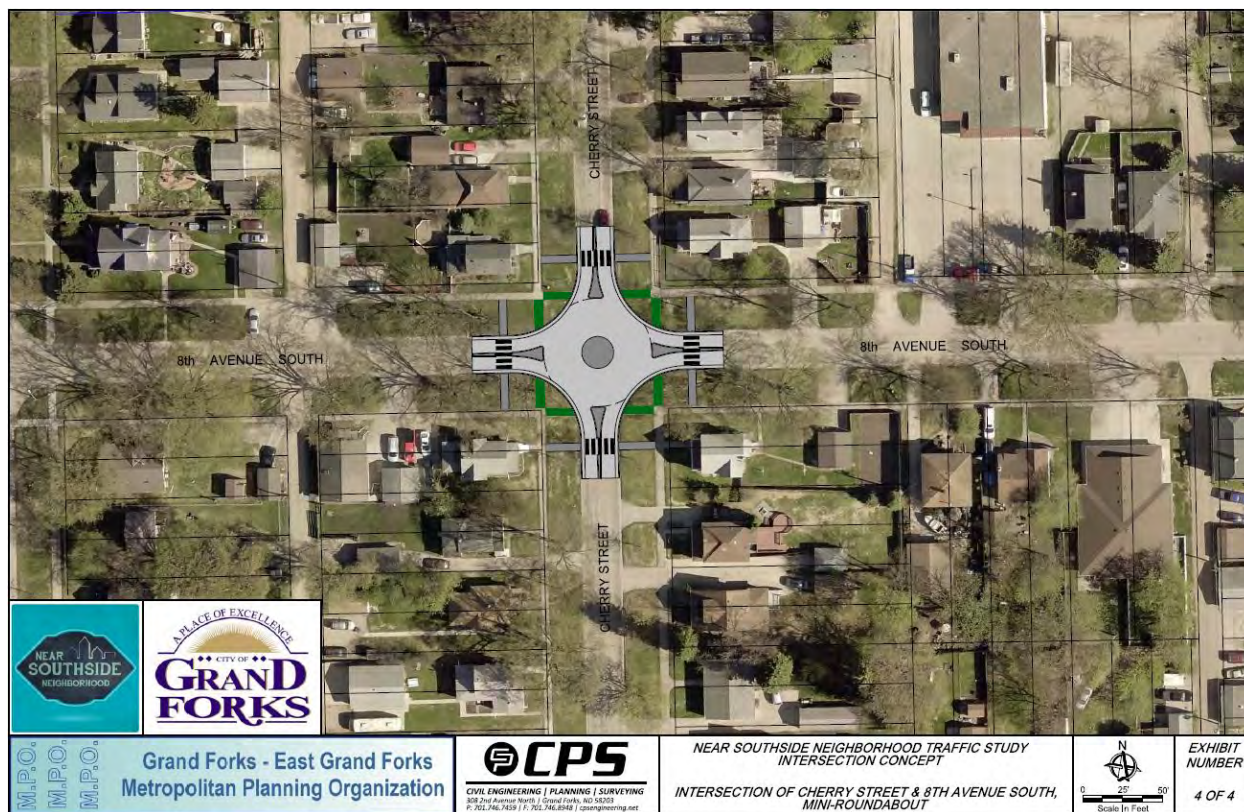
Figure 45. Cherry and 8th concept

This intersection experienced the highest amount of injury and angle crashes within the study area from 2014 to 2016. In order to reduce angle crashes and the injuries that are commonly associated from them, a mini roundabout is recommended. Figure 47 shows a concept of the application at this intersection.

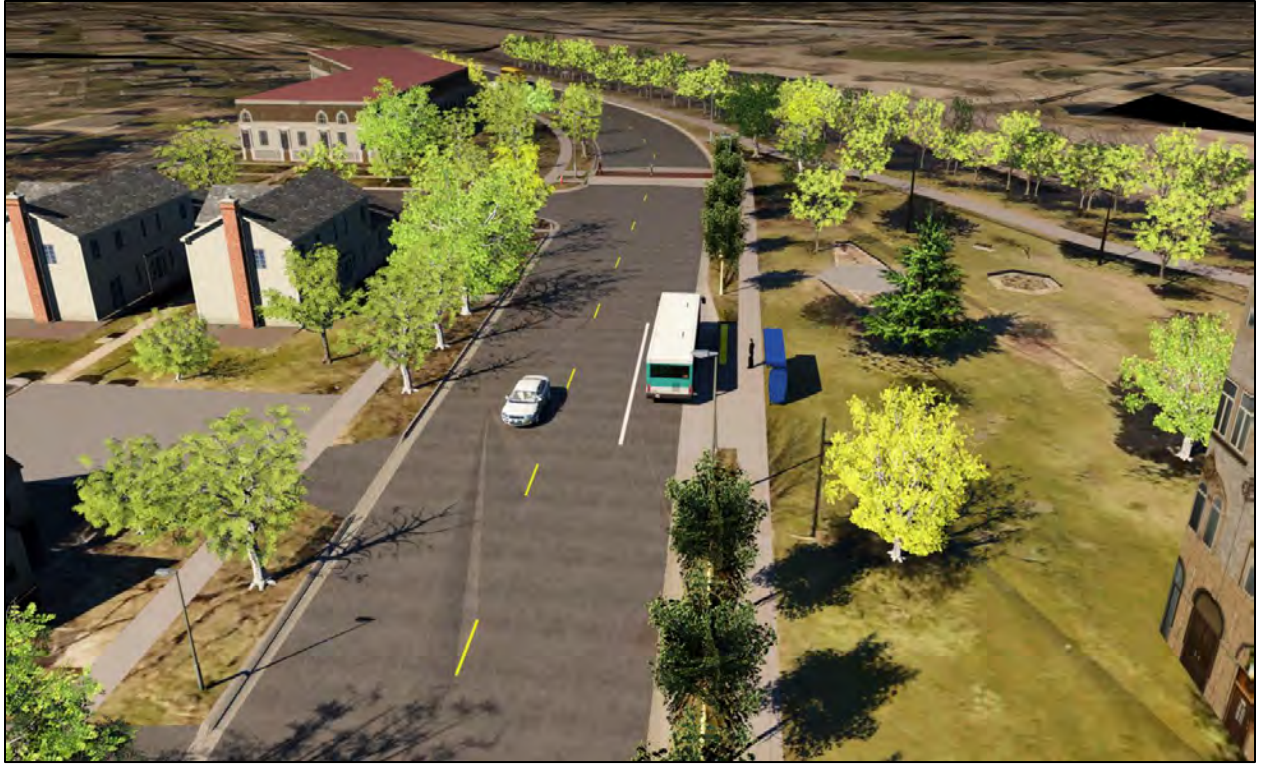
**Figure 47. Bus stop concept**

Some concepts have been developed showing how a new bus stop could be implemented. The intent is to locate it between the two main housing areas and also provide some traffic calming techniques. The concept tries to “land” the bus stop at a location that would allow the construction of a shelter. Given the already large number of passengers boarding, a shelter is needed. The current location of the bus stop does not provide room for a shelter given a multi-use trail exists at the curb.
