MEMORANDUM

From: Shawn Birst, Associate Research Fellow, UGPTI-ATAC

Re: **Nokomis Street Evaluation (Alexandria, MN)**

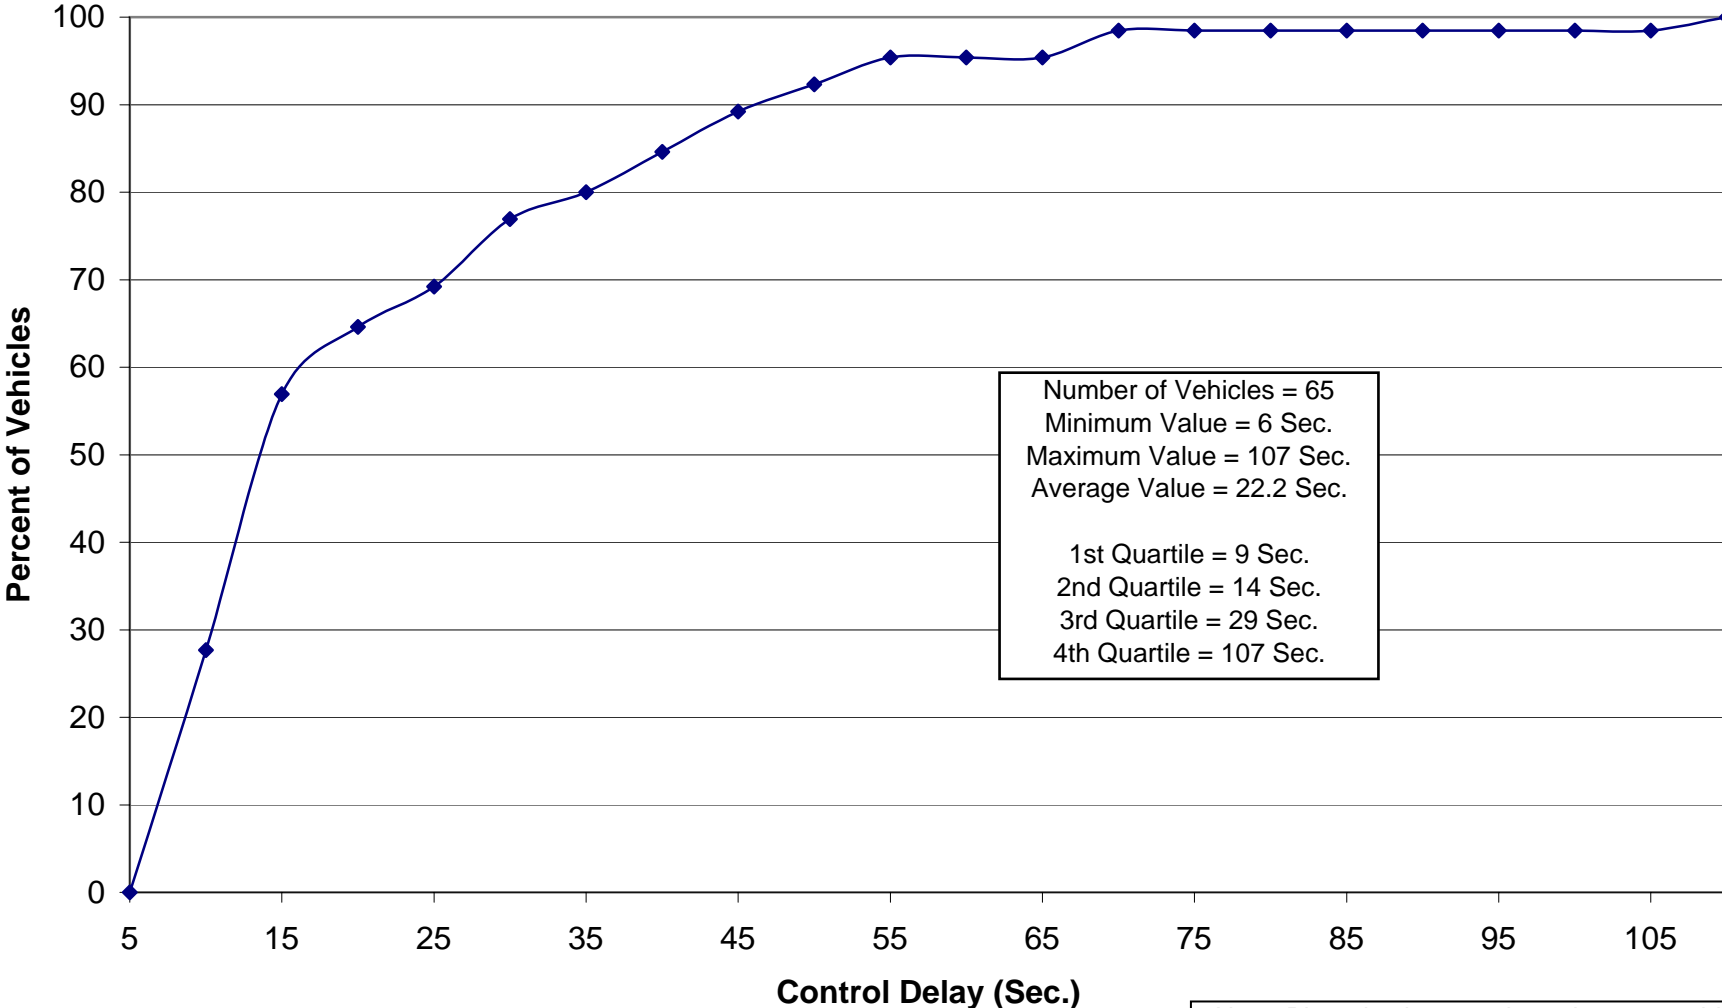
Cumulative Frequency Distribution
TH29 & Lakeview
AM 9-5-02
(7:00 - 9:00)

Note: Plotted values are based on 5 sec. bins

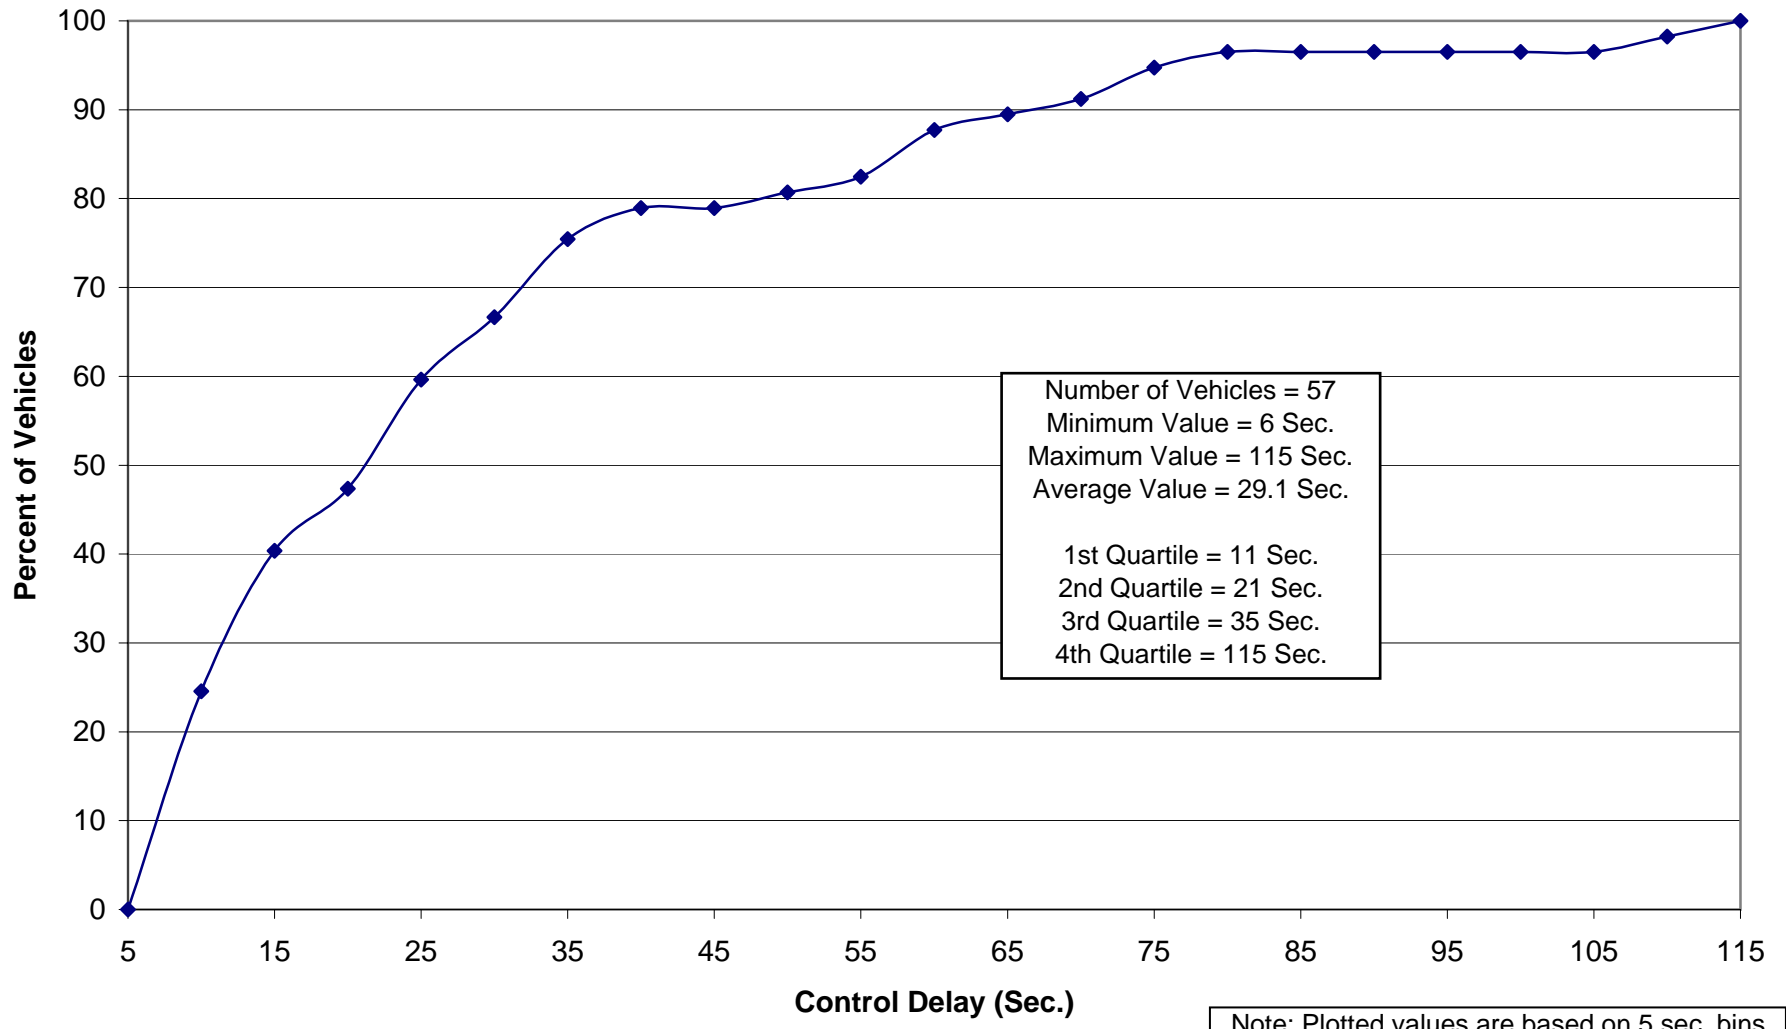
**Cumulative Frequency Distribution
TH29 & Lakeview
MID 8-15-02
(11:00 - 1:00)**

Note: Plotted values are based on 5 sec. bins

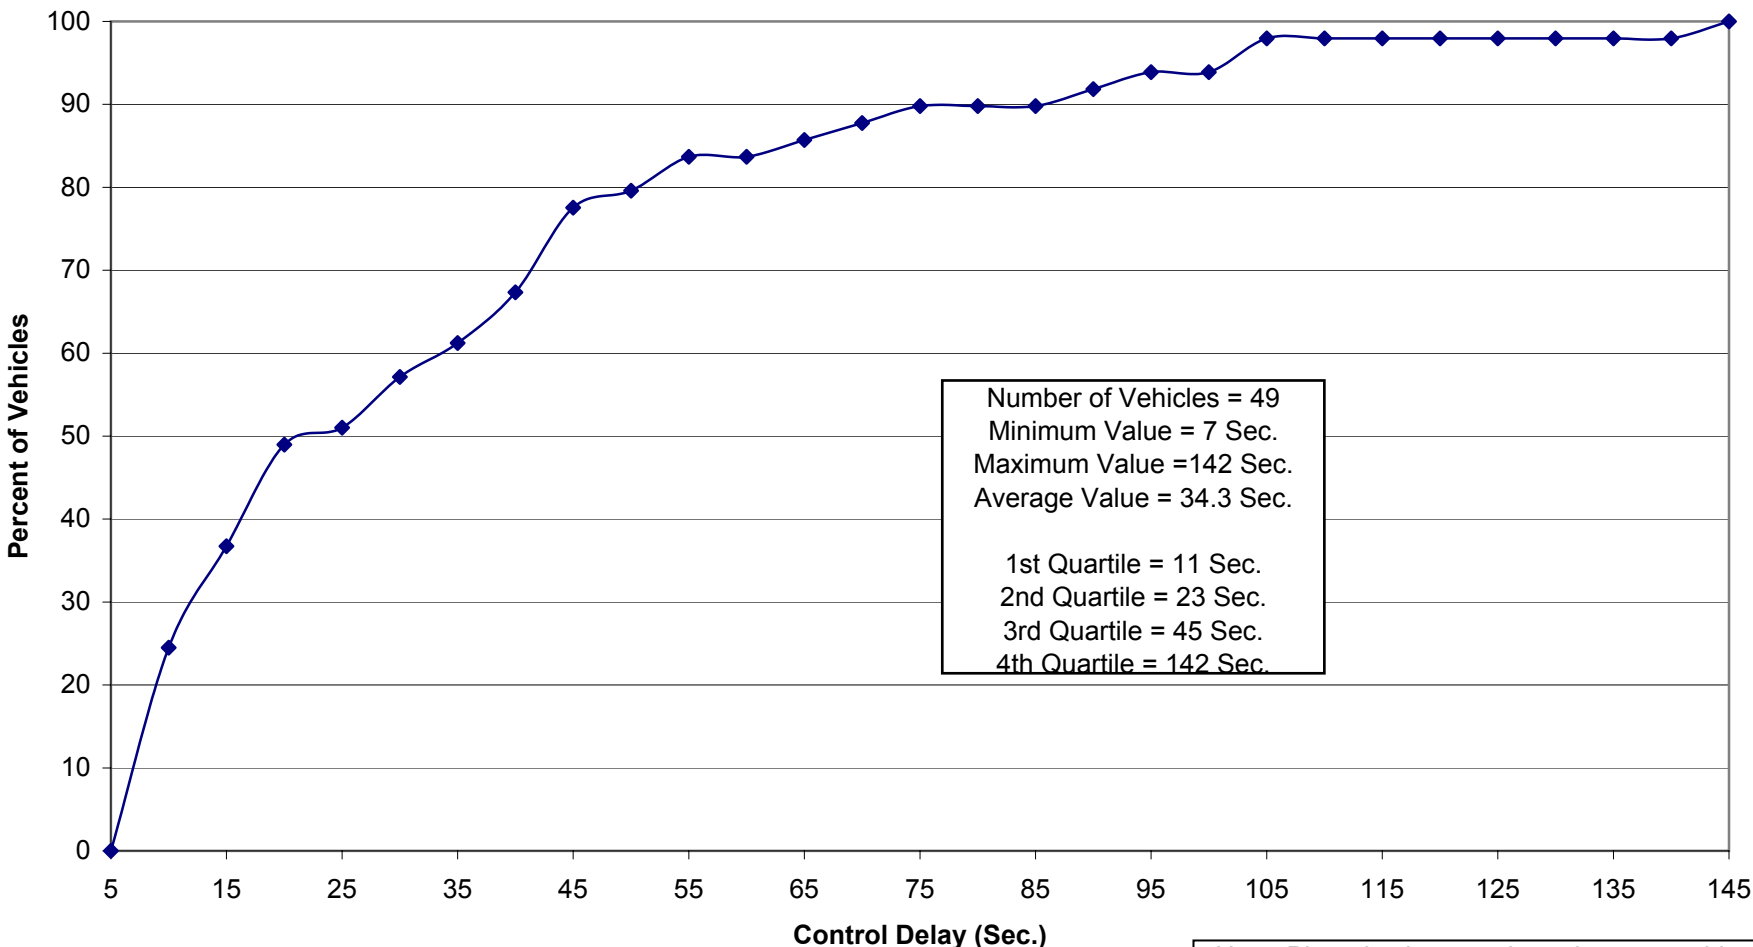
**Cumulative Frequency Distribution
TH29 & Lakeview
PM 8-15-02
(4:00 - 6:00)**

Note: Plotted values are based on 5 sec. bins
