Century Elementary School Safety Study

Final Report

August 2004

**Grand Forks/East Grand Forks
Metropolitan Council of Governments**

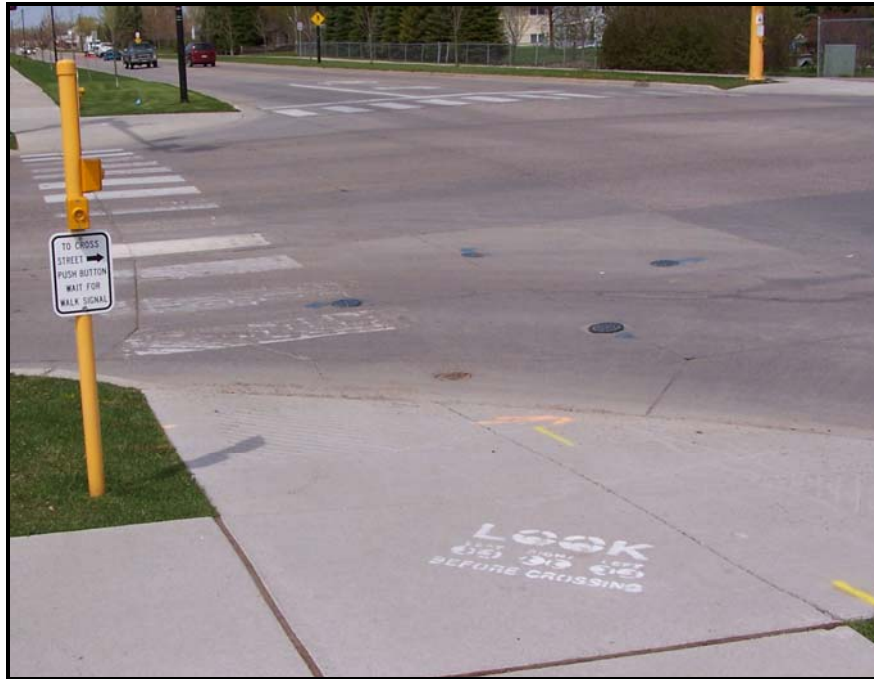
Figure 8. Guidance for safe street crossing.

The vehicle traffic and pedestrian flow at 34th St. and 17th Ave. S was decent overall during our observations. Typically, students waited at the crosswalk until the pedestrian phase displayed WALK (pedestrian image) and motorists did not park in the crosswalk. Supplemental markings guide students to safely cross the

street, which were provided by the SAFE KIDS Walk This Way Campaign (Figure 8). Students were observed running across the street on several occurrences when they were provided the WALK indication. This may be due to the anxiousness to get home or they felt they only were able to cross the street during WALK indication (Figure 9).

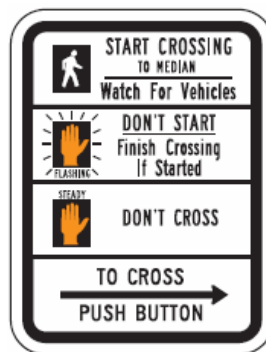
Figure 11. Pedestrian Crossing Sign (R10-3d).

The pedestrian phases at 34th St. and 17th Ave. S. have created some confusion for children and parents. An additional sign stating what the WALK and DON'T WALK indicators mean could be installed. The available guidance sign for pedestrian phases is shown below:

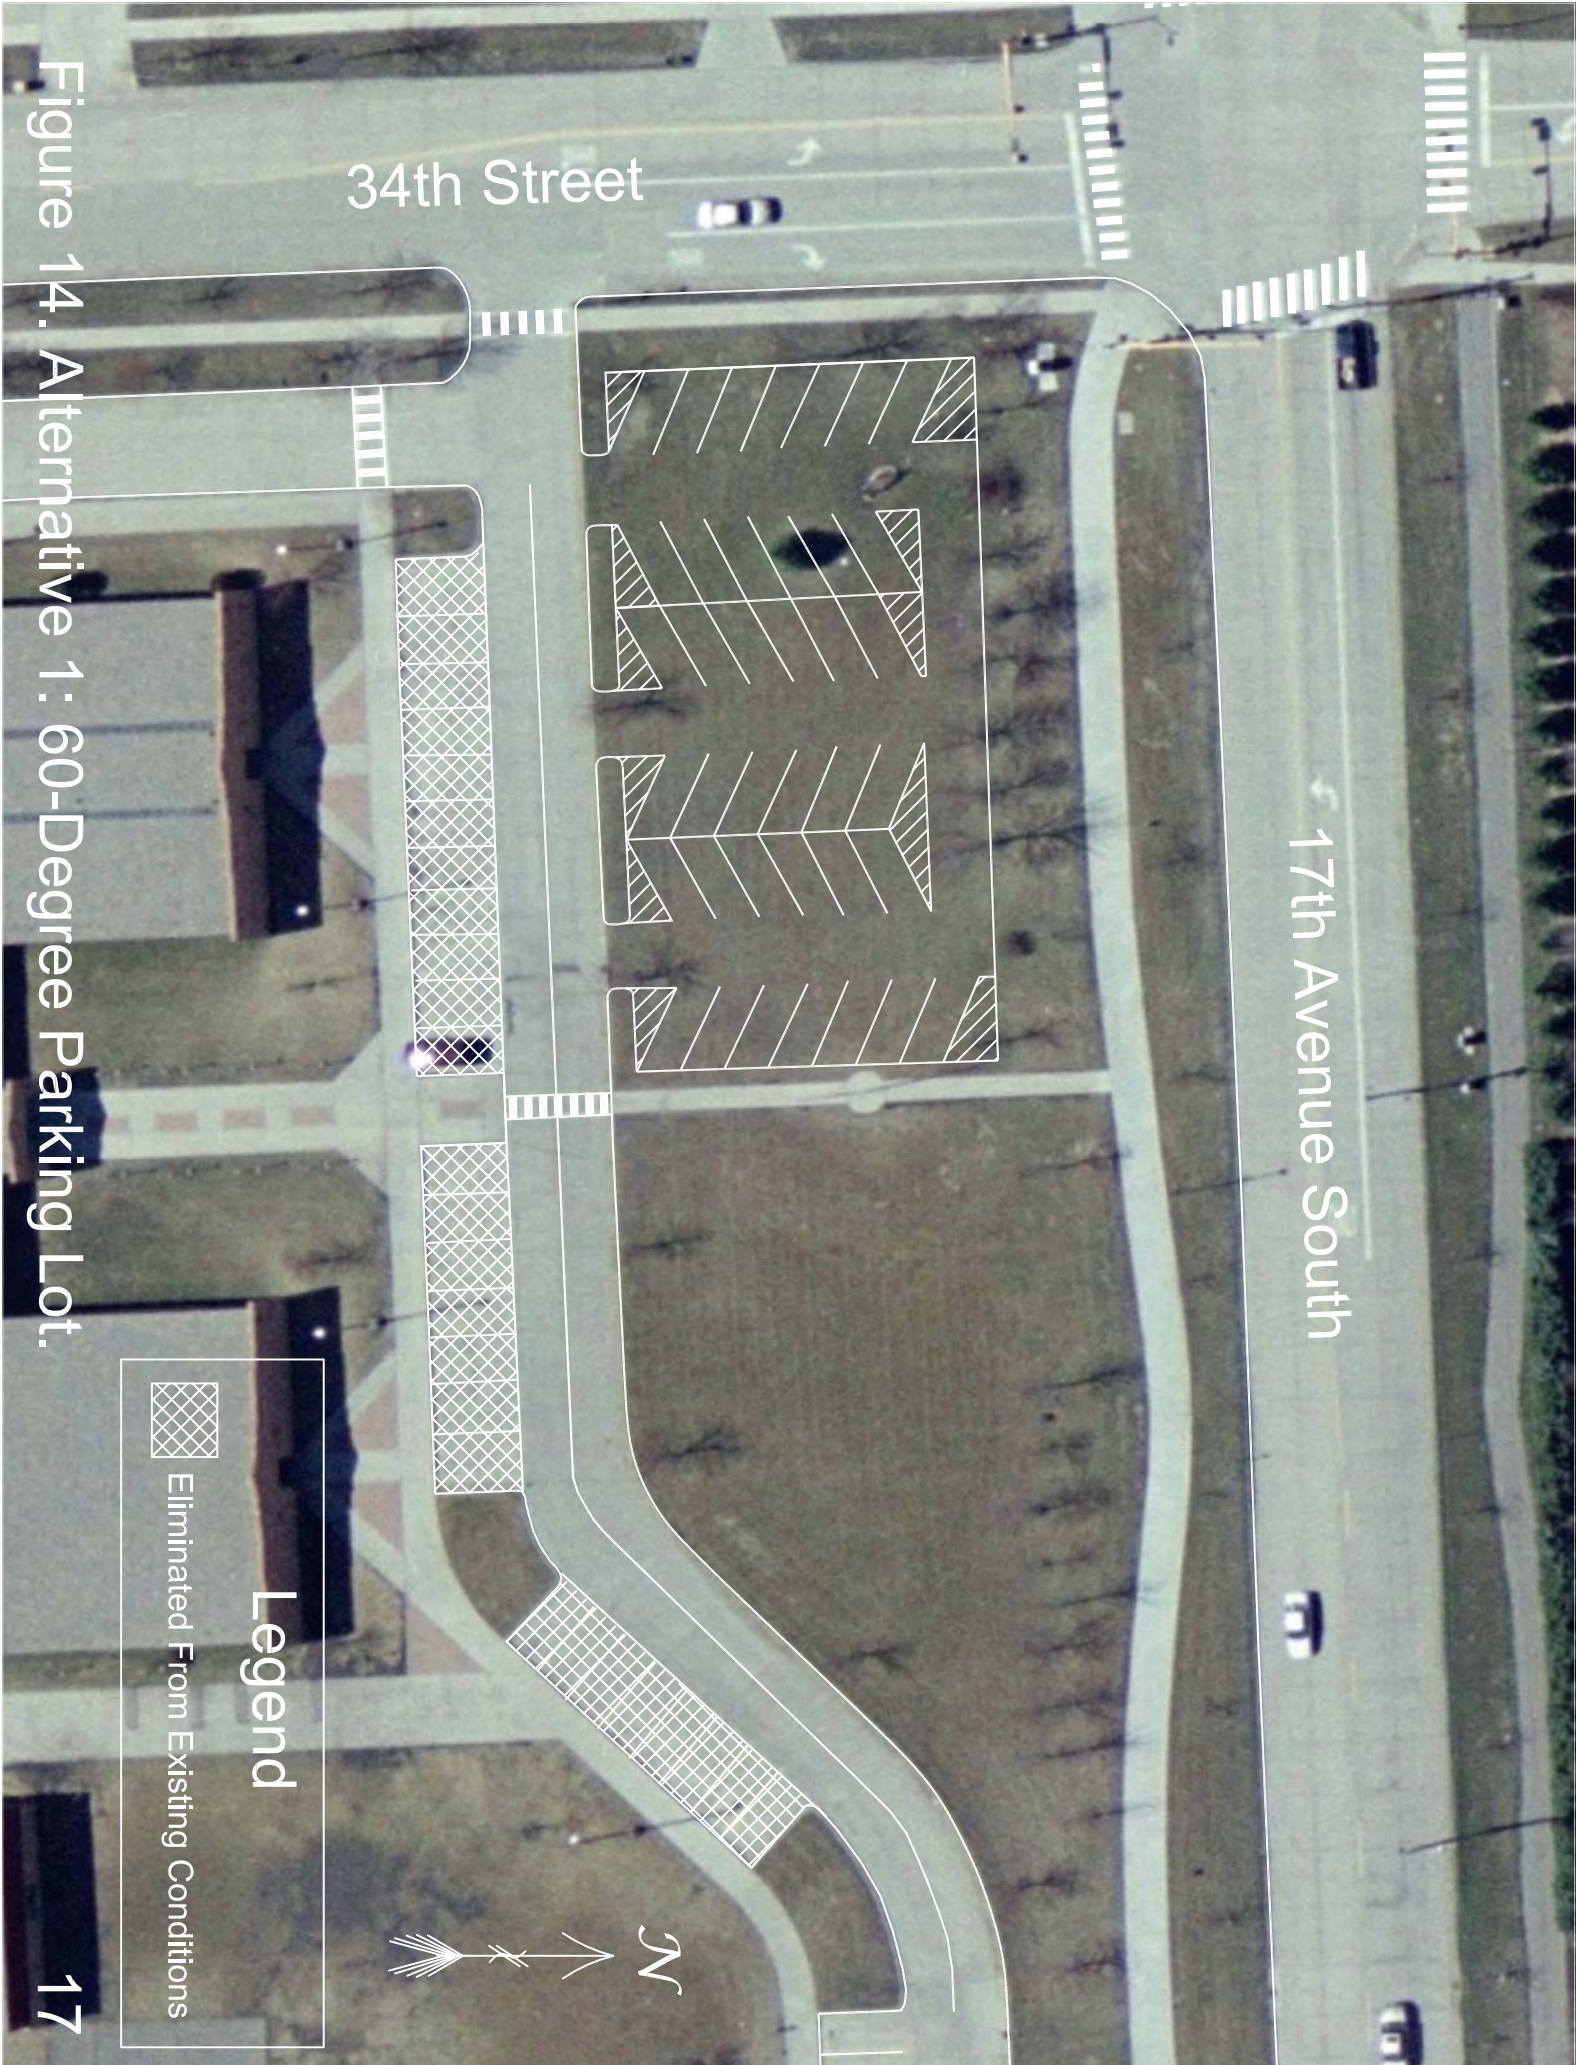
Figure 14. Alternative 1: 60-Degree Parking Lot.

One possible parking lot alternative incorporates 60-degree parking stalls with 1 entrance and 2 exits (Figure 14). This alternative provides 38 spaces and is designed to provide one-way aisle circulation, which reduces the pedestrian/vehicle conflicts. However, the multiple parking lot entrances/exits are not ideal for this location

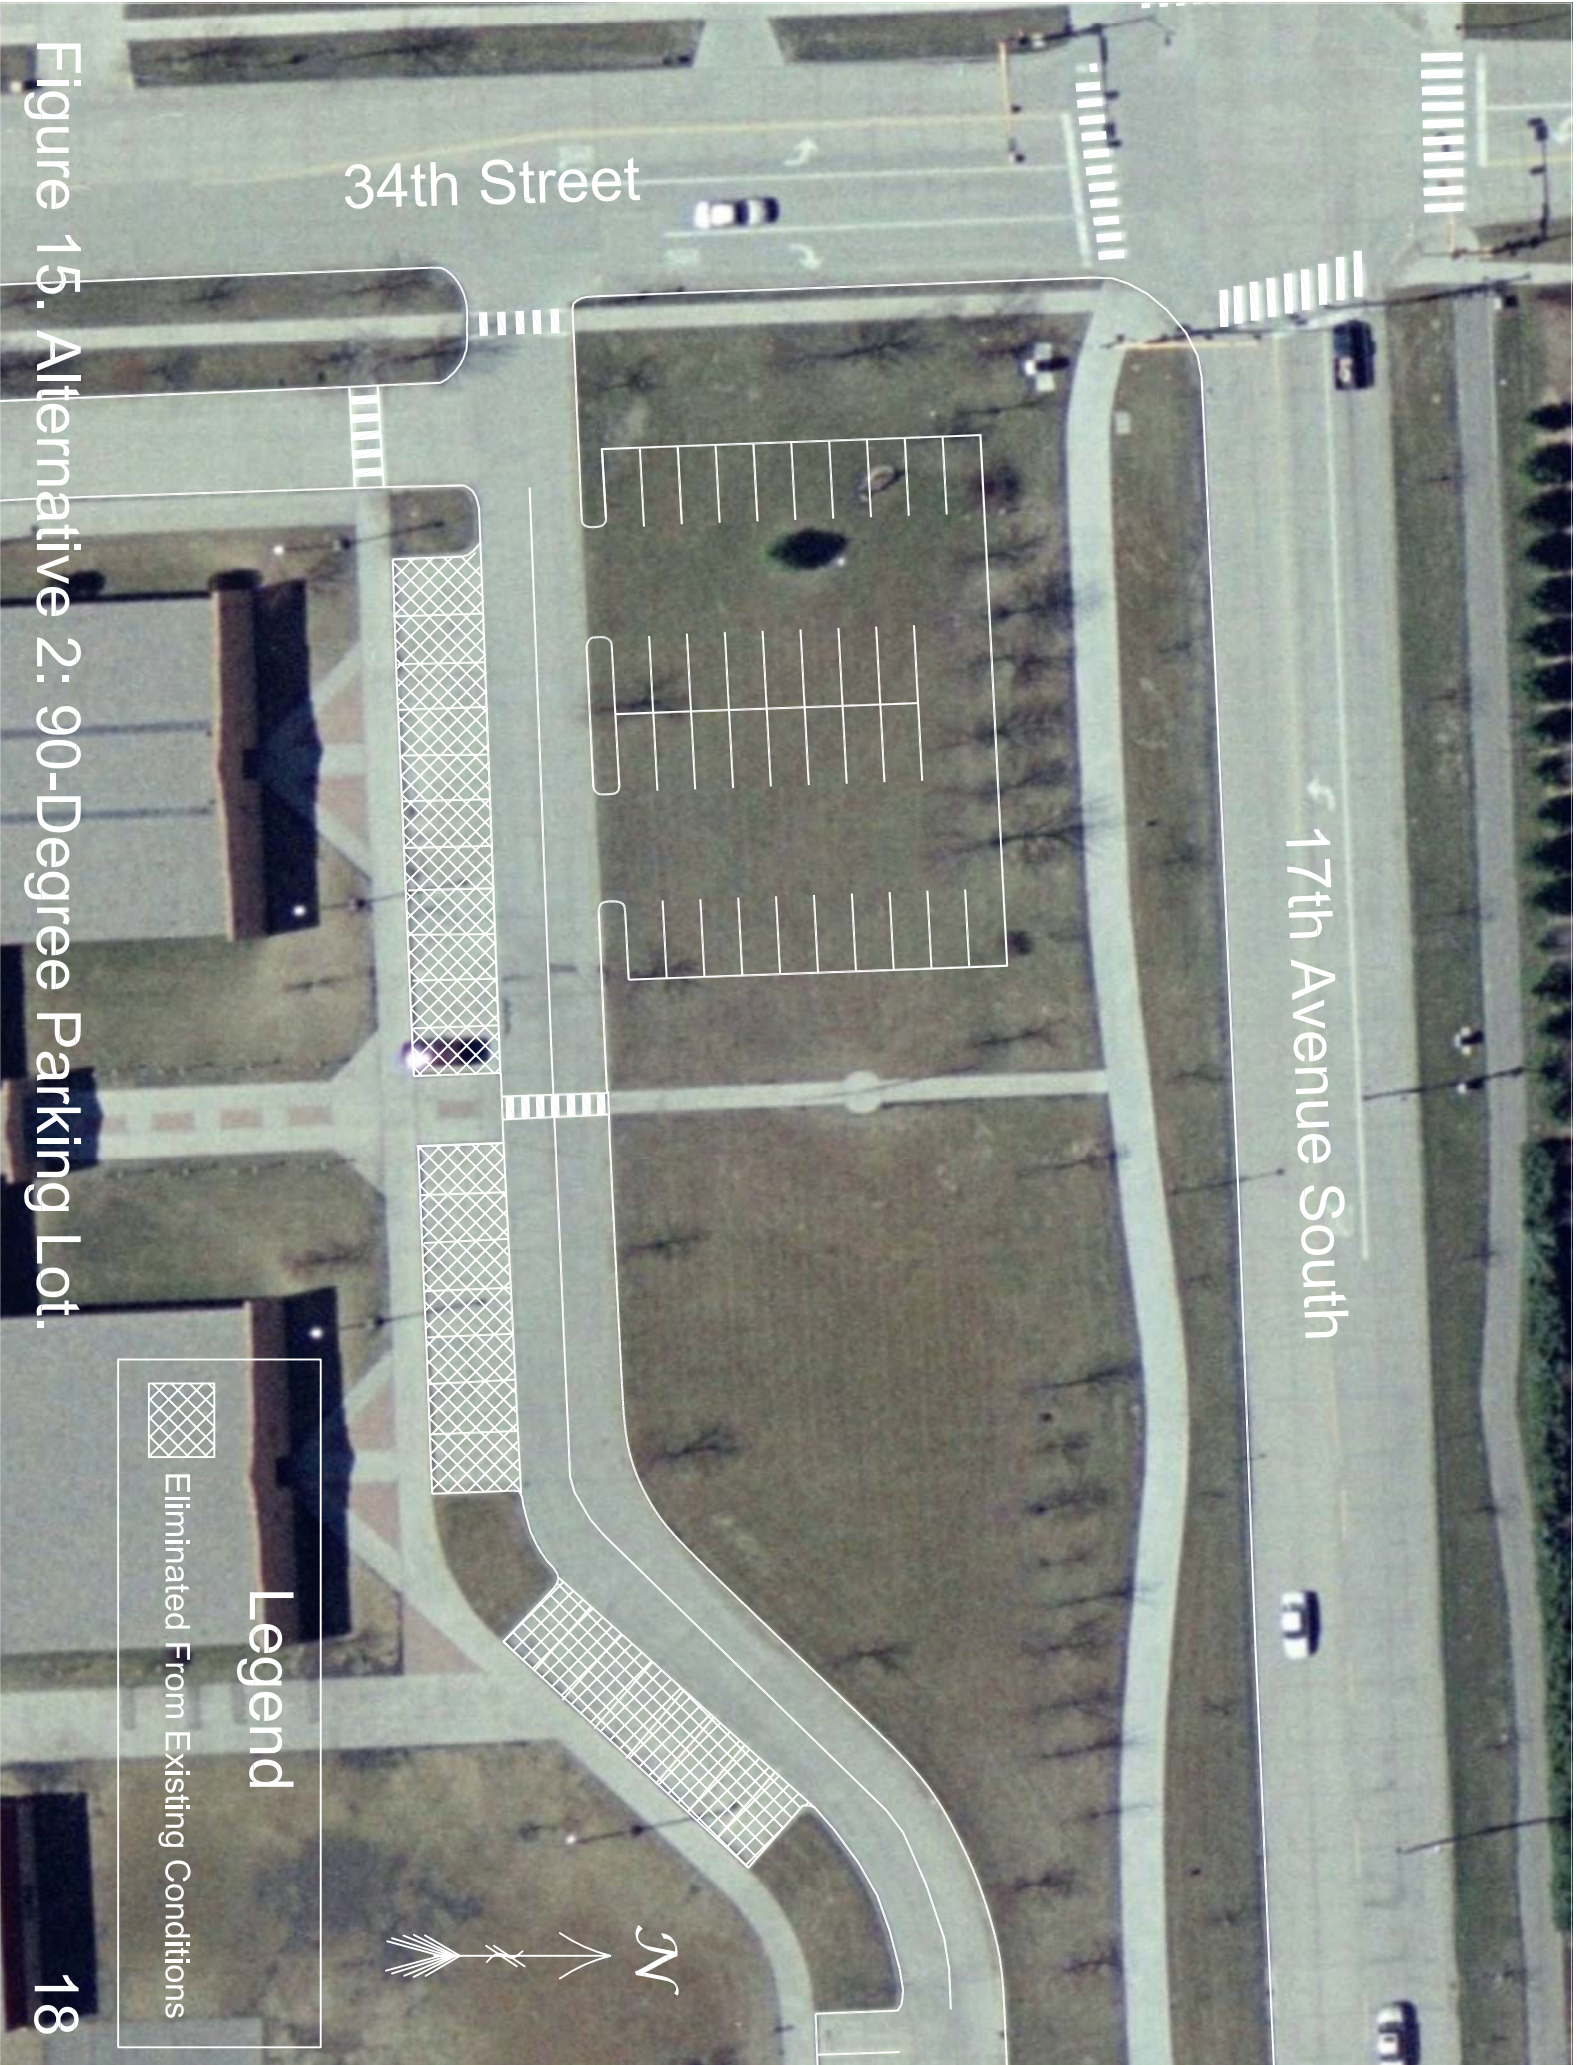
Figure 15. Alternative 2: 90-Degree Parking Lot.

The 90-degree parking alternative provides 36 spaces and two entrances/exits (Figure 15). Although this alternative provides two fewer spaces compared to Alternative 1, the lower number of entrances/exits is more beneficial at this location.

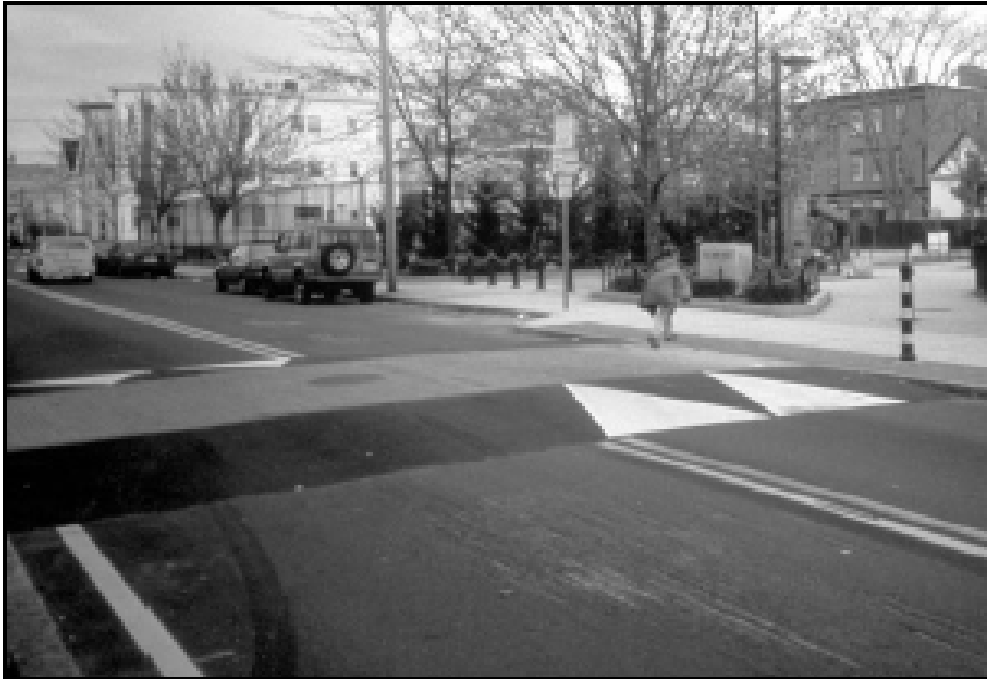
Figure 17. Example of raised crosswalk

Raised crosswalks are used to improve pedestrian safety by providing a more visible crossing area and a control device that will ensure speed compliance. Raised crosswalks are basically elongated speed humps with a pedestrian crosswalk (Figure 17). The construction of raised crosswalk for the school's main entrance could make a safer crossing for pedestrians by reducing speeds and deterring parking over the crosswalk. A detailed drawing of a raised crosswalk is illustrated in Figure 18.
