# **Moorhead Area Integrated Train Detection and Traffic Control System**

## **Phase II-A Evaluation Report**

October 30, 2003

Prepared for:  
**Minnesota Department of Transportation**

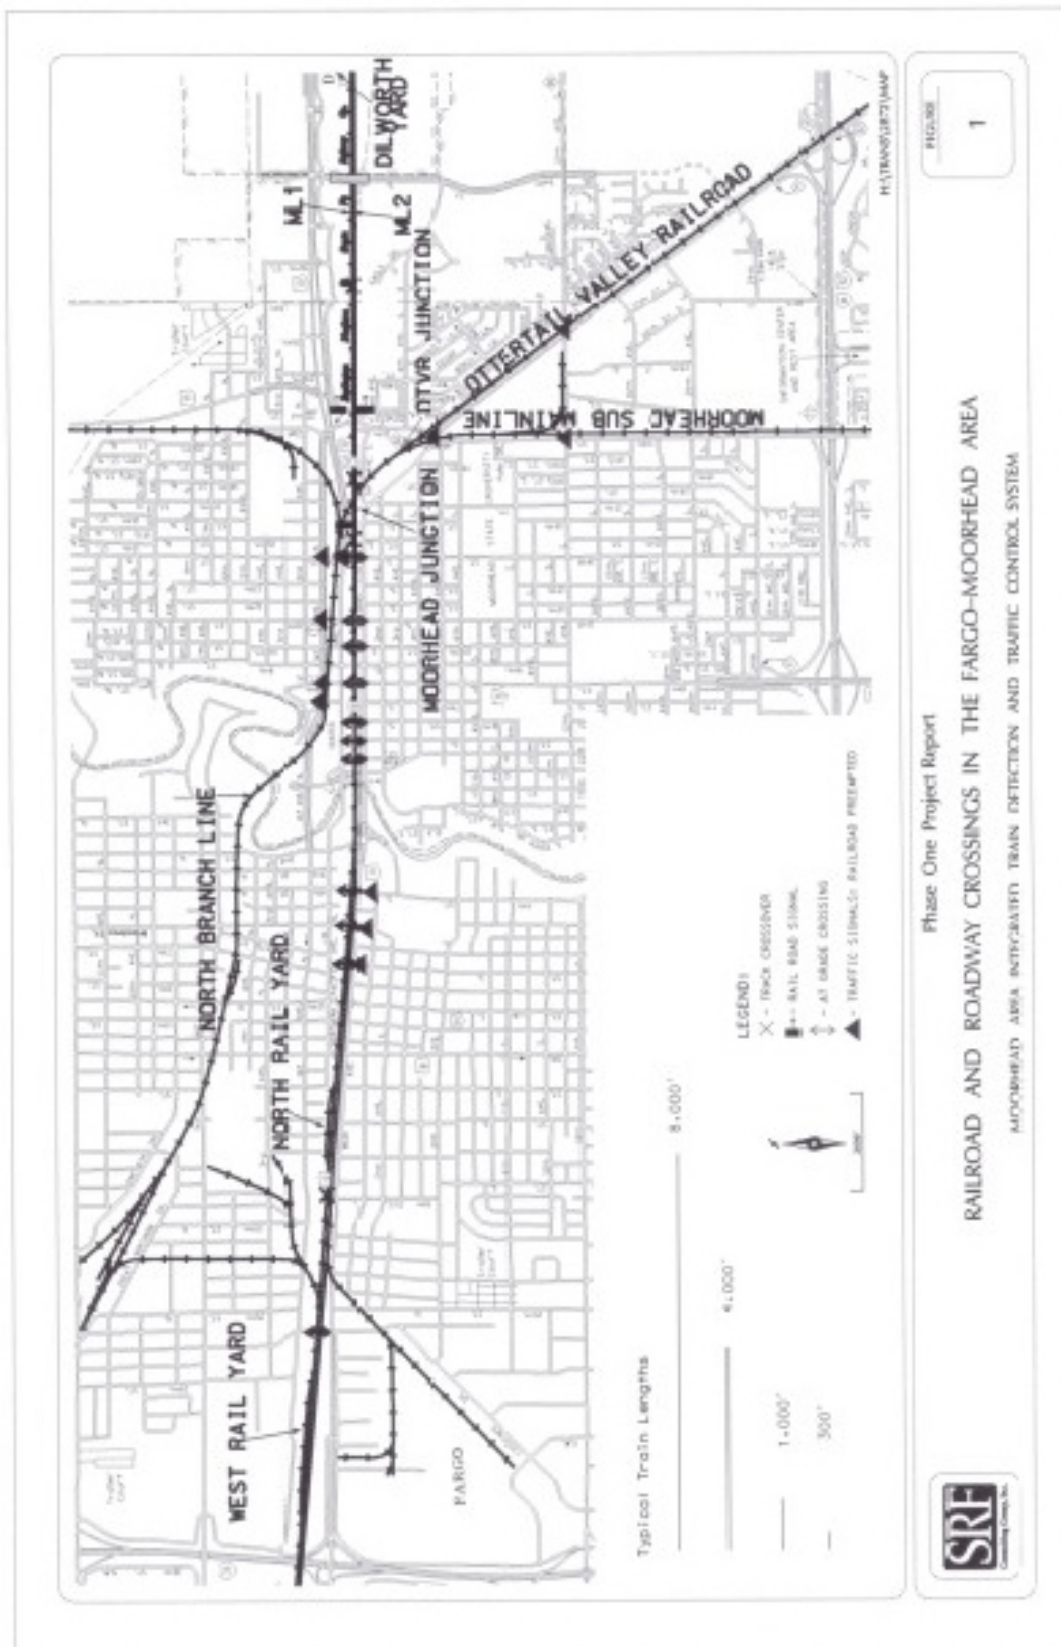
**Figure 1** Project Map (source: MNDOT)

Figure 1 shows a graphical illustration of the project area.

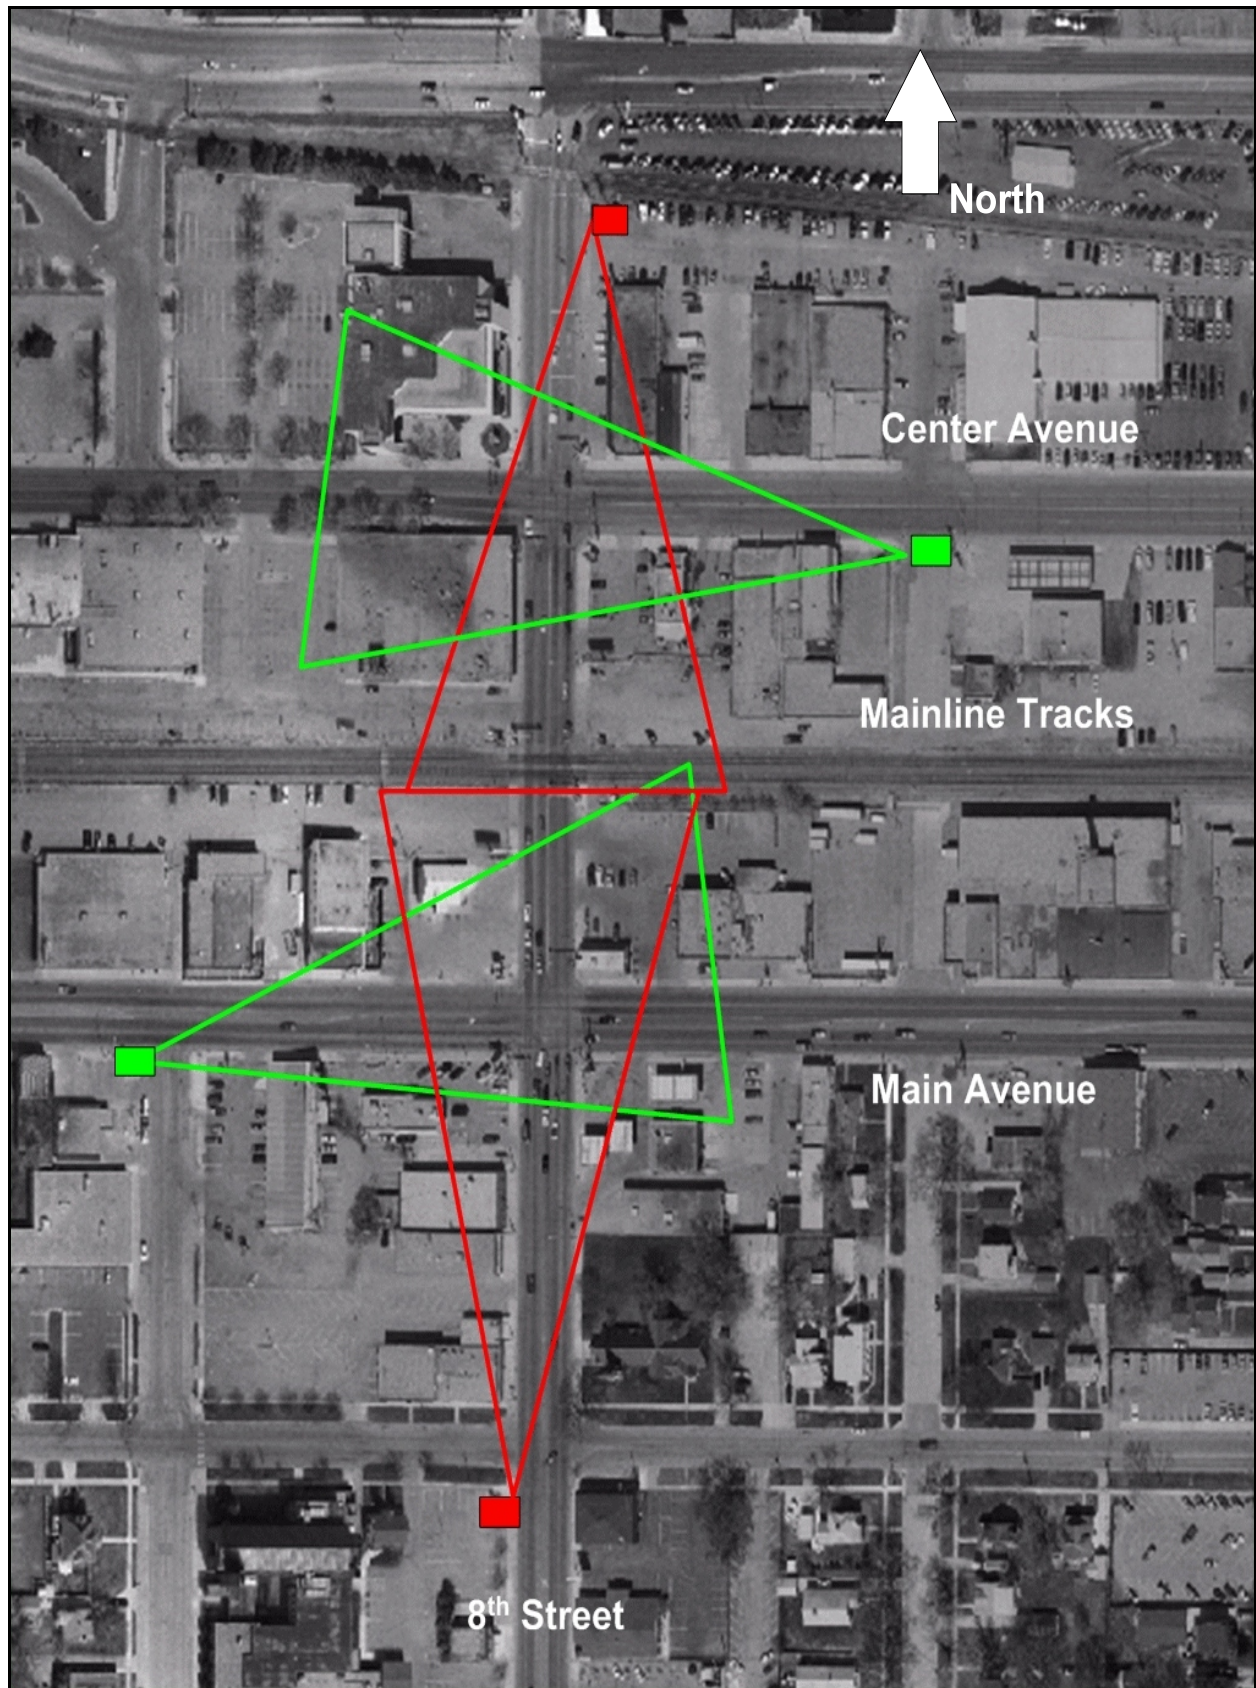
**Figure 2** Locations of Traffic Data Collection using the ATAC's TDCS (video surveillance)

During the initial design of this test plan, the project evaluator began to estimate the level of resources required to cover the four intersections of 8<sup>th</sup> Street and 11<sup>th</sup> Street with Main Avenue and Center Avenue. After conducting a site survey, it was evident that the intersections of 8<sup>th</sup> Street with Main Avenue and Center Avenue were the busiest. It was further determined that due to building locations along these intersections it would be impossible to capture more than two intersection approaches in a single set up of the ATAC’s TDCS. Therefore, the project evaluator proposed to collect data for only the two intersections of 8<sup>th</sup> Street with Main Avenue and Center Avenue. Figure 2 shows the two intersections in more details and illustrates the video surveillance locations..

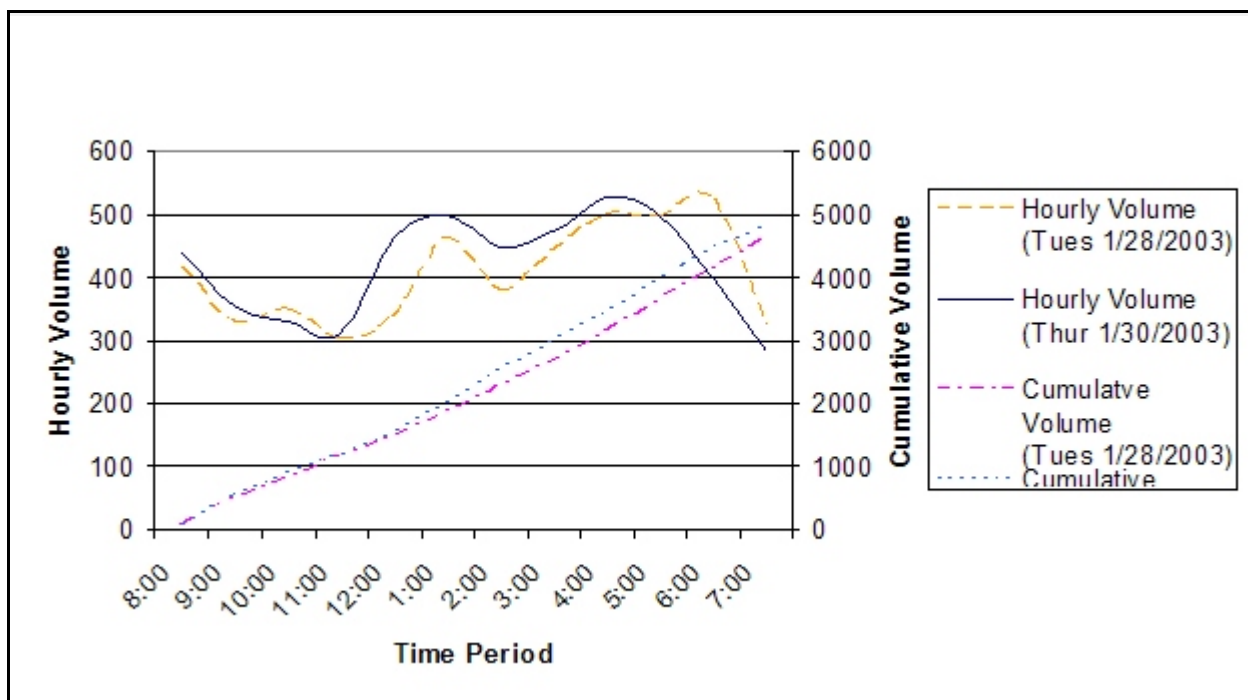
**Figure 3** Example of Traffic Counts Comparisons for “Before” Conditions

This section discusses the results of the traffic data analysis at the two intersections included in the evaluation, i.e., 8<sup>th</sup> Street with Center Avenue and Main Avenue. The results are based on conducting stopped delay measurement from video surveillance data collected at the two intersections. The data collection was for two 12-hour periods for each intersection to capture the east-west and north-south movements independently. Traffic counts on the two days had to be within 10%. Therefore, two additional data collection periods were added to make up for days when the difference was 11% and 12%. The acceptable data collection days had traffic levels that varied by less than 2% on average. Figure 3 shows an example of traffic count comparisons for the two data collection days in the before case.
